AVIATION INVESTIGATION REPORT
A08P0353

CONTROLLED FLIGHT INTO TERRAIN (CFIT)

PACIFIC COASTAL AIRLINES
GRUMMAN G-21A C-FPCK
SOUTH THORMANBY ISLAND, BRITISH COLUMBIA
16 NOVEMBER 2008

Report Number A08P0353

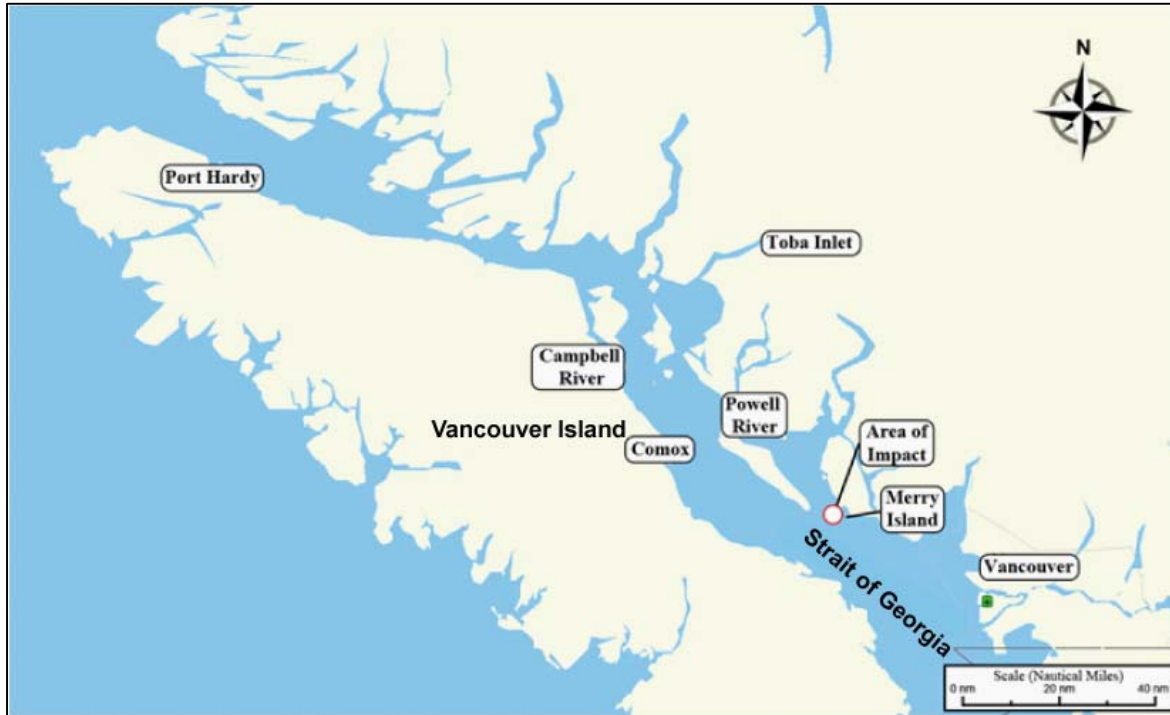
Figure 2. Area map with relevant weather information locations available to the pilot

The next closest weather reporting stations are located across the Strait of Georgia on Vancouver Island (see Figure 2).
