AVIATION INVESTIGATION REPORT

A08Q0051

OUT-OF-TRIM NOSE DOWN CONDITION LEADING TO AN AIRPLANE UPSET

AIRBUS A310-308 C-GPAT

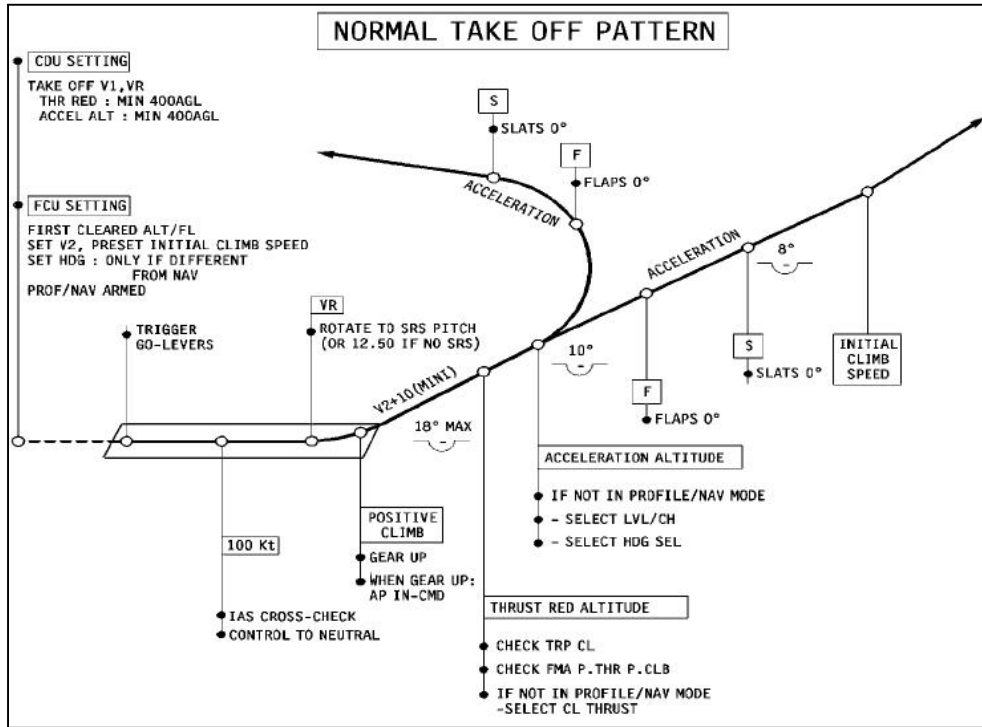
Figure 5. Normal take-off pattern

- The flaps were retracted at 1770 feet agl instead of 3000 feet agl.
- The landing gear was retracted after the flaps were retracted; normally, the landing gear is retracted immediately after take-off when the rate of climb is positive.
- Levelling off occurred with a pronounced pitch correction, 100 feet above the authorized altitude. At the time of level-off, vertical acceleration reached 0.25 g.

According to the FOM (see Figure 5), the PF should have asked the PM to engage the AP shortly after take-off. However, the unusual take-off run and climb sequence delayed the AP's engagement. Engaging the AP immediately after take-off would have reduced the crew's workload by taking control of the aircraft's direction, heading hold, speed management, automatic trim of the THS and capture of the assigned altitude.
