AVIATION INVESTIGATION REPORT
A14O0077

LOSS OF CONTROL - COLLISION WITH WATER

CESSNA 185E, C-FYKU
TAYLOR LAKE, ONTARIO
24 MAY 2014

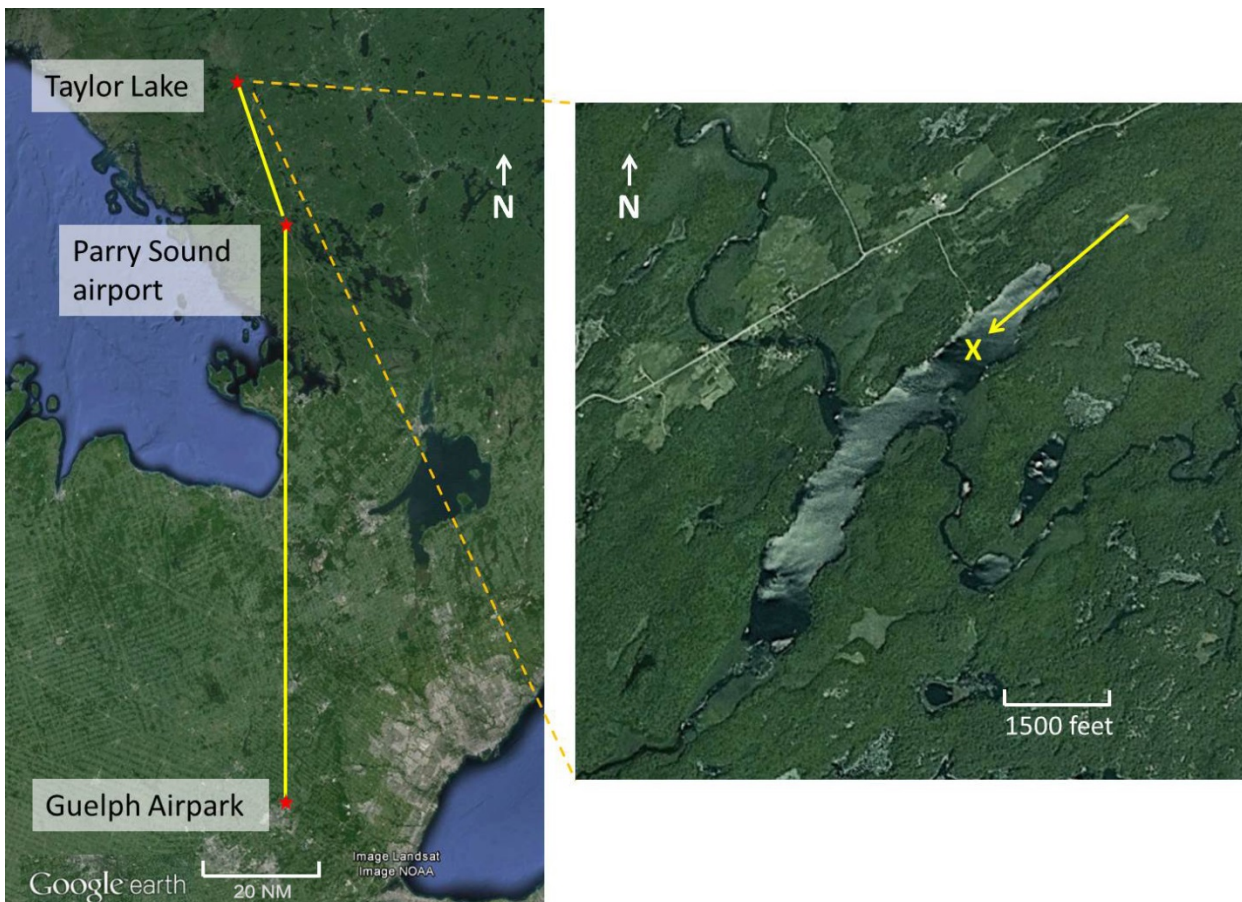
Figure 1. Taylor Lake maps showing the route, direction of approach, and accident location.
(Source: Google Earth, with TSB annotations)

Taylor Lake is located 20 nautical miles (nm) north of Parry Sound. The lake is approximately 1.2 nm long, 700 feet wide and has a northeast to southwest orientation. The aircraft's approach was stable and the landing was conducted in a southwest direction. The aircraft touched down at approximately 0740¹ in the centre area of the lake, about 1500 feet from the northeast end (approach end). There was no wind on the morning of the occurrence and the water surface conditions were smooth and glassy.
