AIR TRANSPORTATION SAFETY INVESTIGATION REPORT A19Q0015

RUNWAY INCURSION

Aéroports de Montréal

Montréal/Pierre Elliott Trudeau International Airport, Quebec

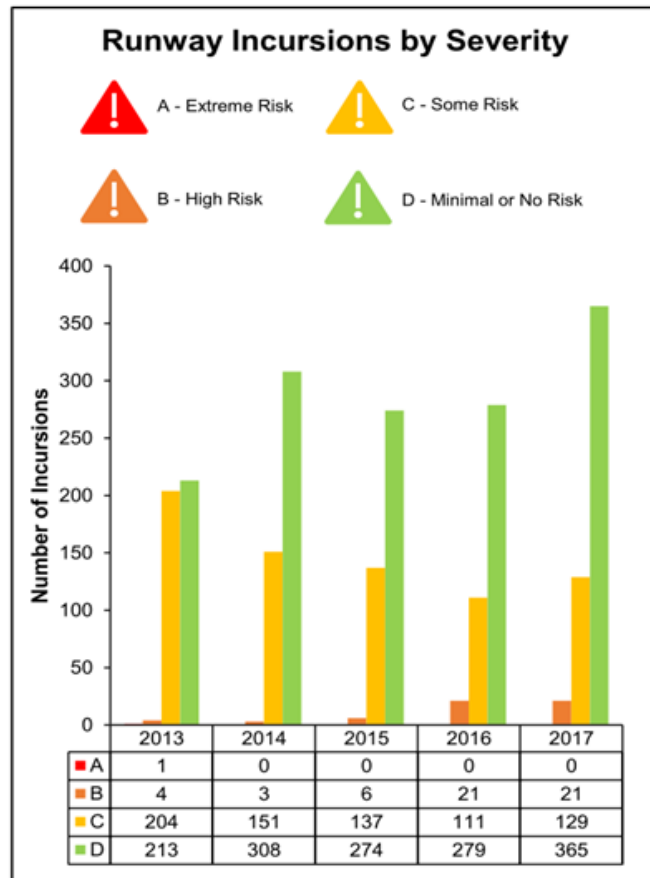
From 2013 to 2017, NAV CANADA recorded an average of 445 runway incursions in Canada each year.⁴⁶ While the majority of these incursions posed little to no risk, there were 21 high-severity (Category B) events in each of the last 2 years of this study (Figure 5). These could have led to a collision with other aircraft, damage, injuries, or death.

Figure 5. Runway incursions in Canada from 2013 to 2017, categorized by severity (Source: NAV CANADA)
