Air Transportation Safety Investigation Report A20W0035

LOSS OF CONTROL AND COLLISION WITH TERRAIN

RS Ultra Kangook MF powered paraglider (basic ultralight), C-ILQJ
Gibbons, Alberta, 4.5 NM NW
13 May 2020

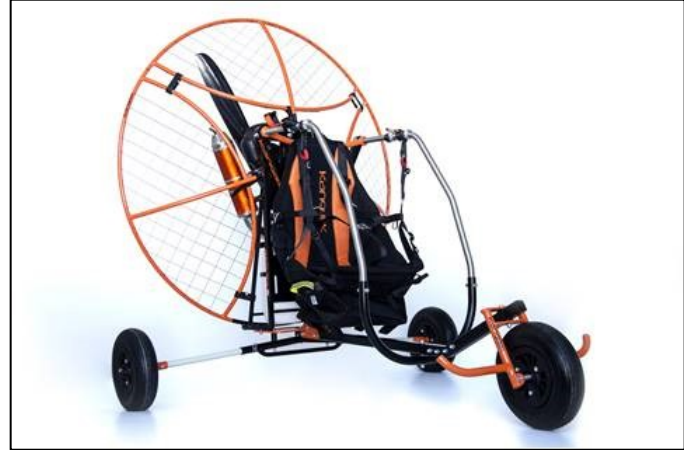
The RS Ultra Kangook MF is a powered paraglider (Figure 3). The occurrence aircraft was registered with Transport Canada as a basic ultralight and was equipped with an APCO Vista HP S canopy.²

A post-accident examination of the canopy, suspension and control lines, trike, and engine were completed. No anomalies were found that would have contributed to the loss of control.

Figure 3. A representative RS Ultra Kangook MF with third party trike wheel assembly. Canopy not shown. (Source: Kangook Paramotors)
