AIR TRANSPORTATION SAFETY INVESTIGATION REPORT A21P0111

COLLISION BETWEEN AN AIRCRAFT AND A WATER TAXI

Tofino Air
de Havilland DHC-2 MK. I (Beaver), C-FMXR
and
Eagle Adventures Water Taxi
Water taxi C12997BC (*Rocky Pass*)
Tofino, British Columbia
18 October 2021

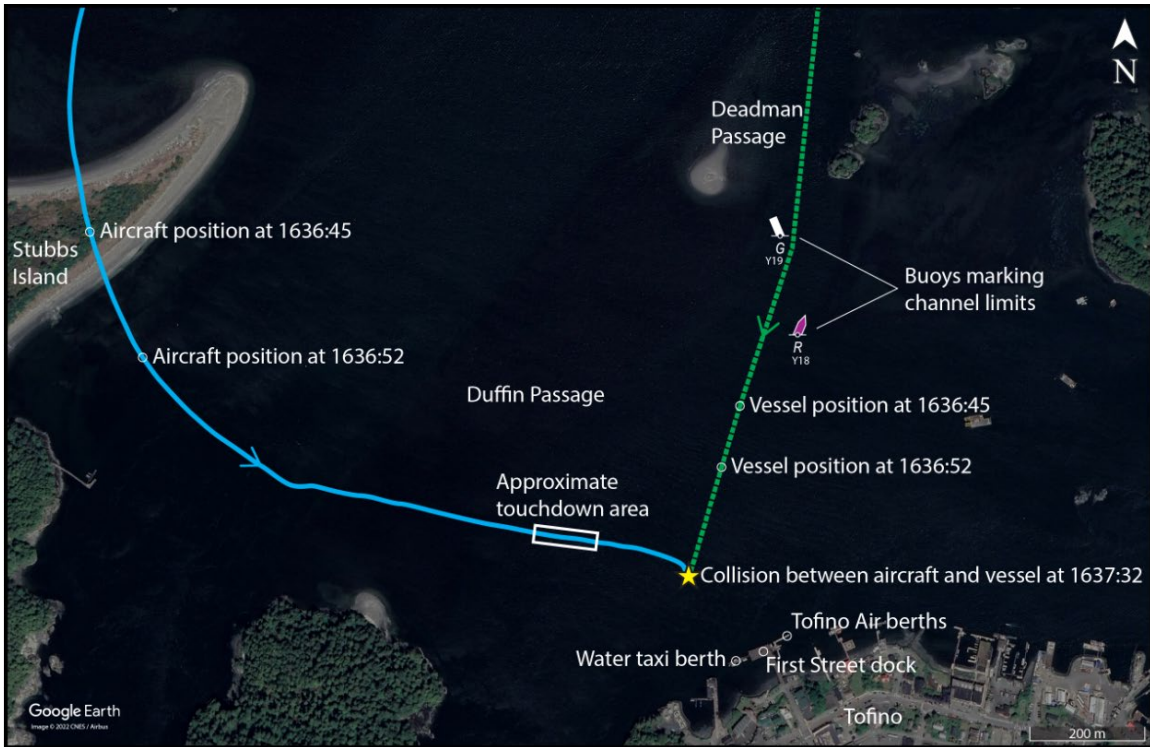
Figure 1. Map showing the approximate track of the aircraft (solid line) and vessel (dashed line) (Source: Google Earth, with TSB annotations)

At around 1636, the *Rocky Pass* exited Deadman Passage and proceeded toward the First Street dock at a speed of approximately 25 knots (Figure 1). Once at the dock, the plan was to offload the 2 passengers and pick up some more passengers who were waiting to go to Ahousaht. The operator completed a scan of the area as he exited the channel and did not observe any traffic that would impede his intended route.

When the *Rocky Pass* was about 300 m off the First Street dock, the operator reduced the vessel's speed⁵ while waiting for the berth to become available. Shortly after, 2 water taxis at the dock made radio calls announcing their intentions to depart, and the operator of the *Rocky Pass* re-engaged the engines to continue his approach to the dock. At this time, the operator noticed people on the dock waving their arms and trying to warn him of something, which caused him to turn and look behind him through his starboard window. He then saw the aircraft on the water, approximately 15 m away, heading toward the vessel. The operator applied port helm to the vessel in an attempt to avoid a collision. However, within seconds (at 1637:32), the aircraft and the vessel collided in position 49°09.34' N, 125°54.71' W. The aircraft's propeller blades and left float made contact with the vessel's starboard side.

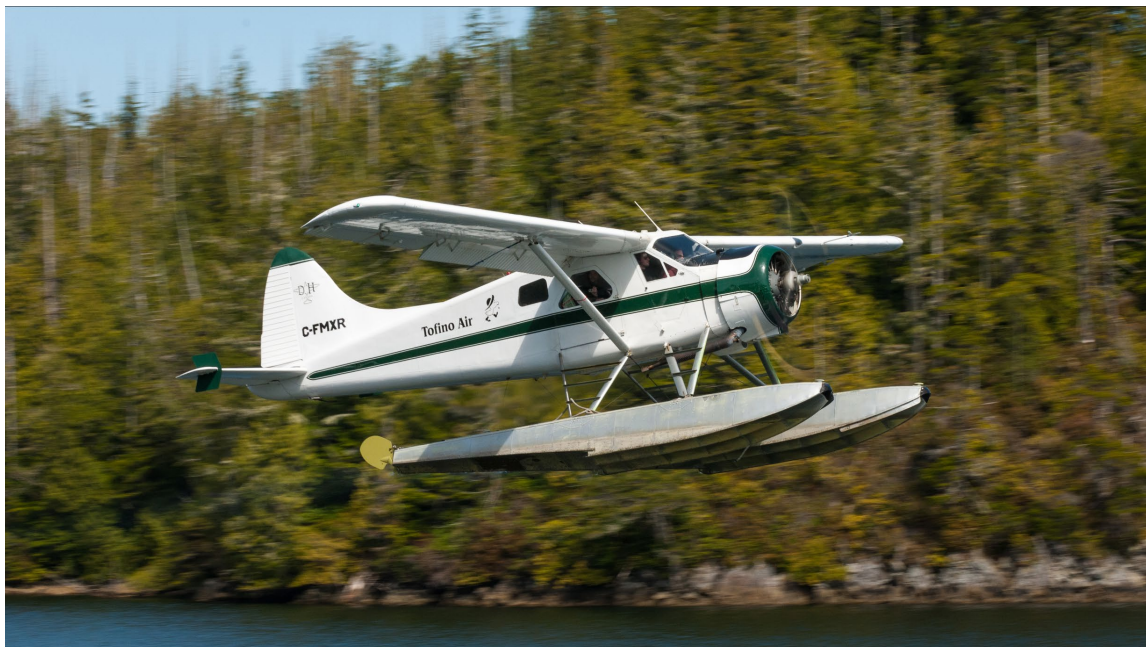
Figure 2. Occurrence aircraft (Source: Third party, with permission)

The de Havilland DHC-2 MK. I (Beaver) is a single-engine, high-wing, propeller-driven aircraft equipped with EDO 58-4580 floats (Figure 2).

The aircraft's propeller and left float were damaged as a result of the collision.

Both propeller blades were twisted and bent and had nicks and gouges on the leading edges. One blade was missing approximately 8 cm of the outboard tip and the other blade had a nick that was 1.2 cm deep and 1.7 cm long on the leading edge located approximately 6.3 cm from the blade tip.

The rear-left float strut was disconnected and there was damage to the rear spreader bar. There was significant damage and wrinkles to the outboard and inboard skins of the left float.

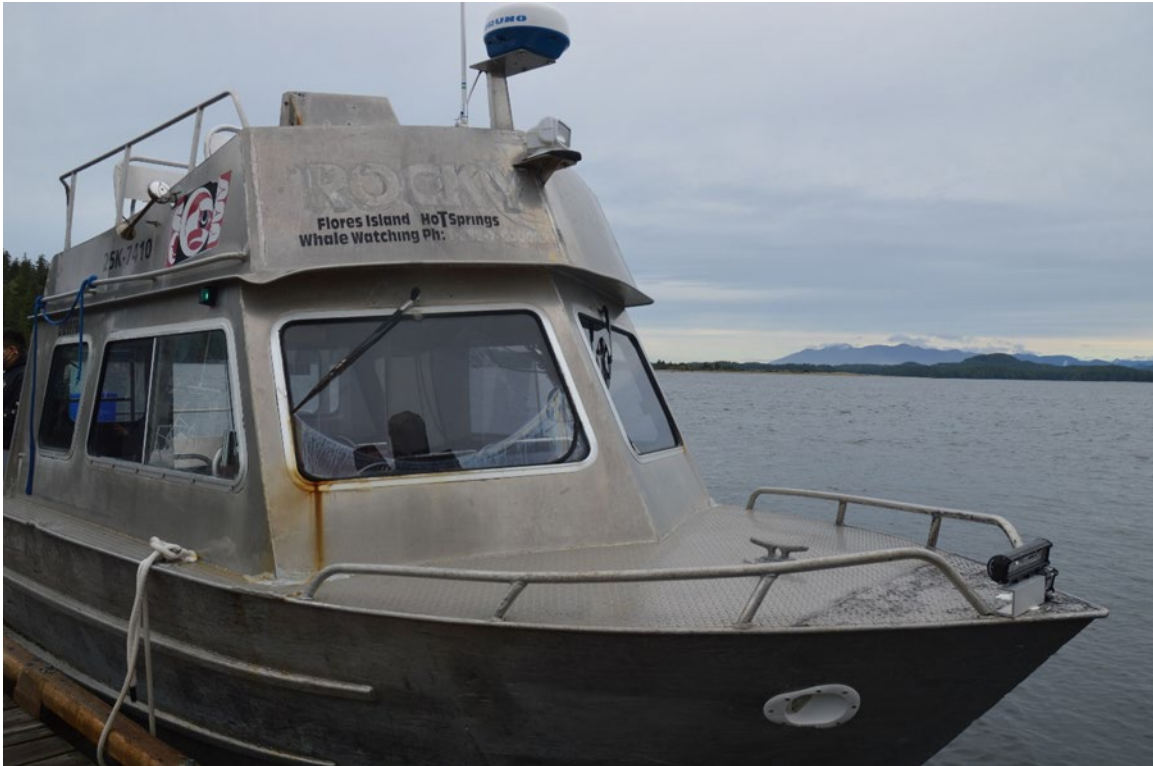
Figure 3. Photo of the Rocky Pass (Source: TSB)

The vessel sustained minor damage as a result of the collision.

The *Rocky Pass* (Figure 3) has an aluminum hull and an enclosed cabin that contains the conning station and a passenger seating area. The passenger seating area consists of rows of seats arranged on either side of a centre aisle. The conning station is located on the forward starboard side of the cabin and has a seat for the operator. The conning station has

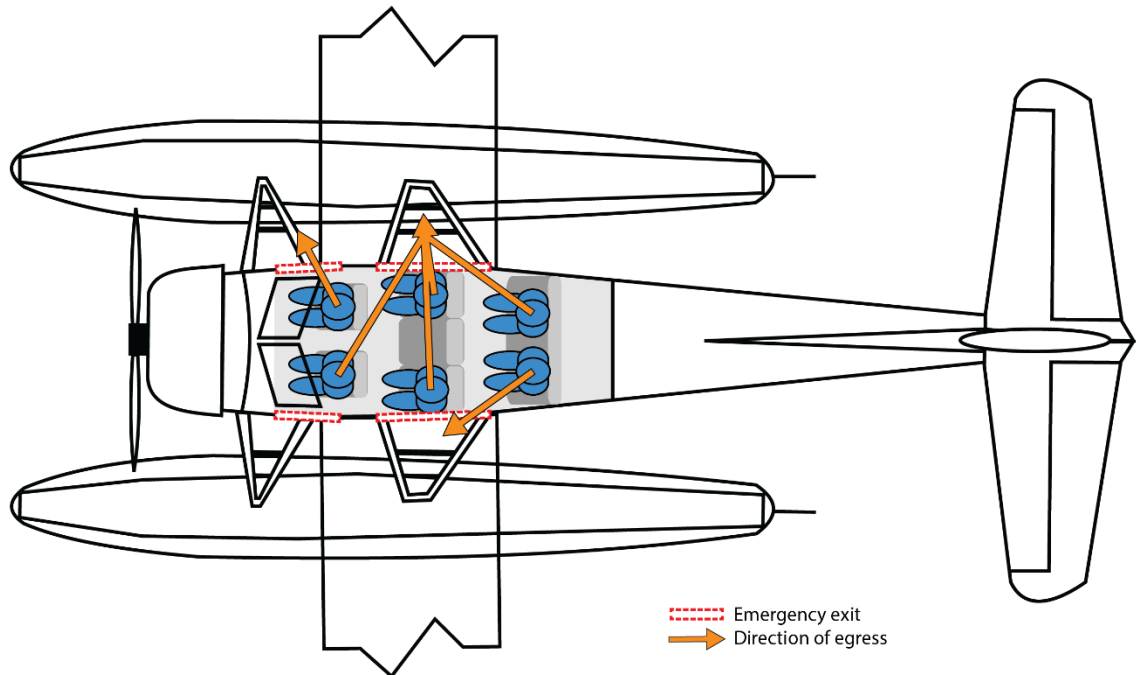
Figure 6. Illustration showing the direction of egress by each occupant (Source: TSB)

The occupants all exited the aircraft before it capsized and were transported to the First Street dock by various vessels that had come to provide assistance. The passenger seated in the front-right seat exited through the front-right door. The passenger seated in the rear-left seat exited through the middle-left door. The remaining passengers and the pilot exited through the middle-right door (Figure 6). The passenger seated in the rear-left seat exited onto the left wing and was able to board a vessel without entering the water. All other occupants entered the water after exiting the aircraft and had to swim a short distance to board various vessels. The investigation was unable to determine the exact amount of time each occupant was in the water; however, it was estimated to be up to 2 minutes.

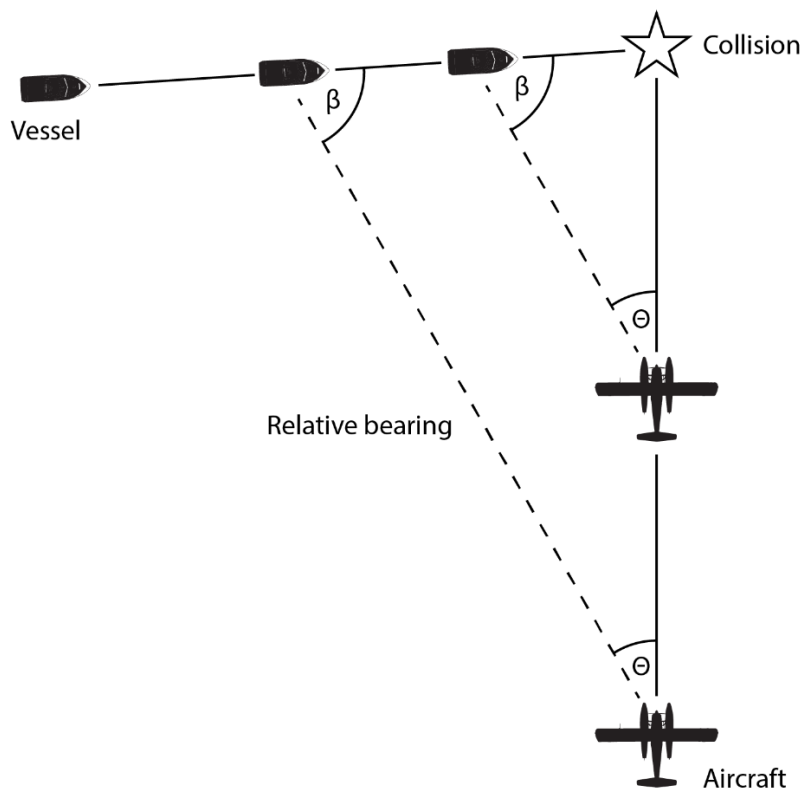
Figure 7. Diagram of a scenario where a target appears stationary (Source: TSB)

The perception of objects moving toward a viewer is affected by the physiological differences in foveal and peripheral vision. People are sensitive to motion in their peripheral vision; however, this sensitivity diminishes when objects are stationary in the visual field. If a target is converging on the same point as the viewer, relative bearing will remain constant and it is likely that the target will not be noticed because its position on the retina appears stationary (Figure 7). Also, although both the foveal and peripheral vision systems can detect movement, the foveal system is better at detecting slow movement, while the peripheral system is better at detecting rapid movement.¹⁷

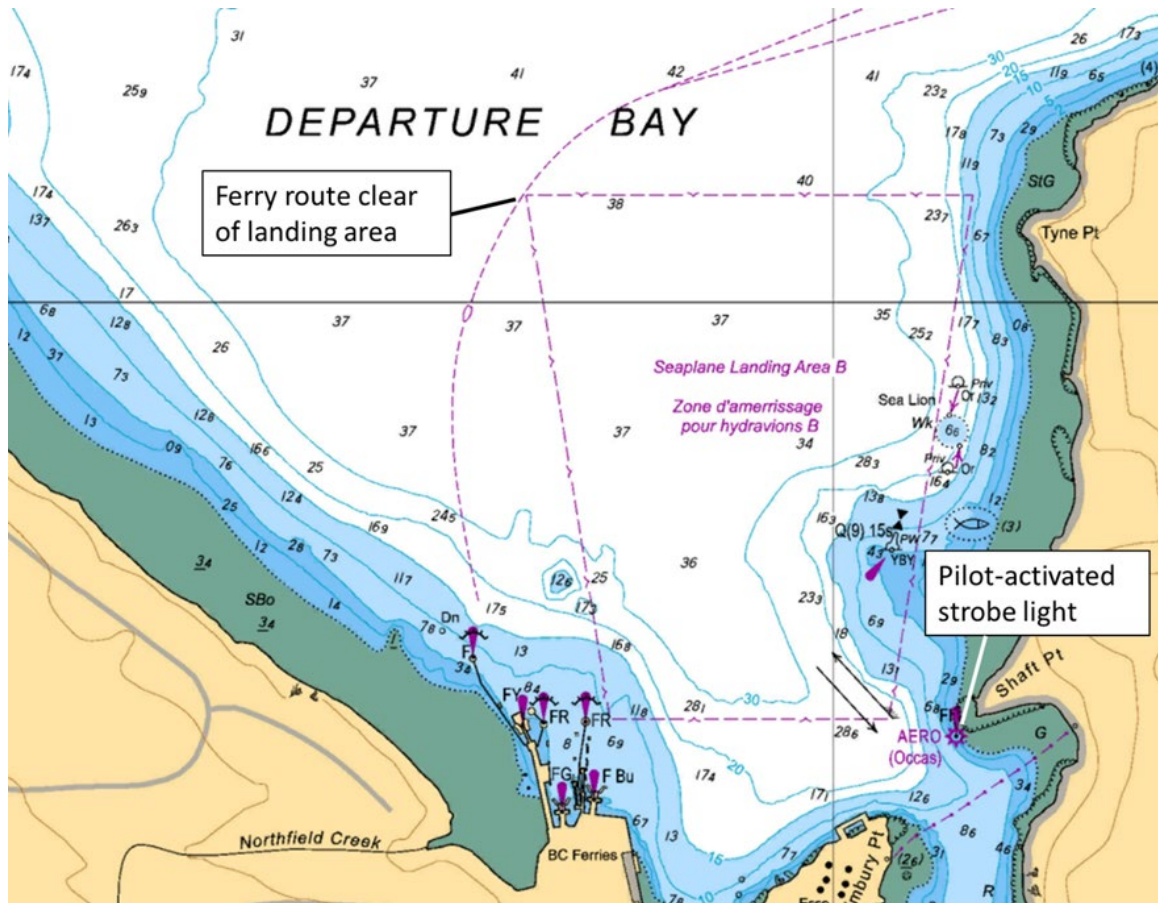
Figure 10. Chart of Nanaimo harbour showing the designated seaplane landing area, ferry routing, and pilot-activated strobe light (Source: Canadian Hydrographic Service, with TSB annotations)

Designated landing area information is available to vessel operators on nautical charts and sailing directions. As an example, Figure 10 shows the nautical chart for Nanaimo harbour, which has both a designated landing area and a pilot-activated light. There is no designated landing area for floatplanes in Tofino.
