AIR TRANSPORTATION SAFETY INVESTIGATION REPORT A23W0100

COLLISION WITH TERRAIN

Synergy Aviation Ltd.
Robinson Helicopter Company (RHC) R44 II, C-GNEC
Grande Cache, Alberta, 30 NM ENE
25 August 2023

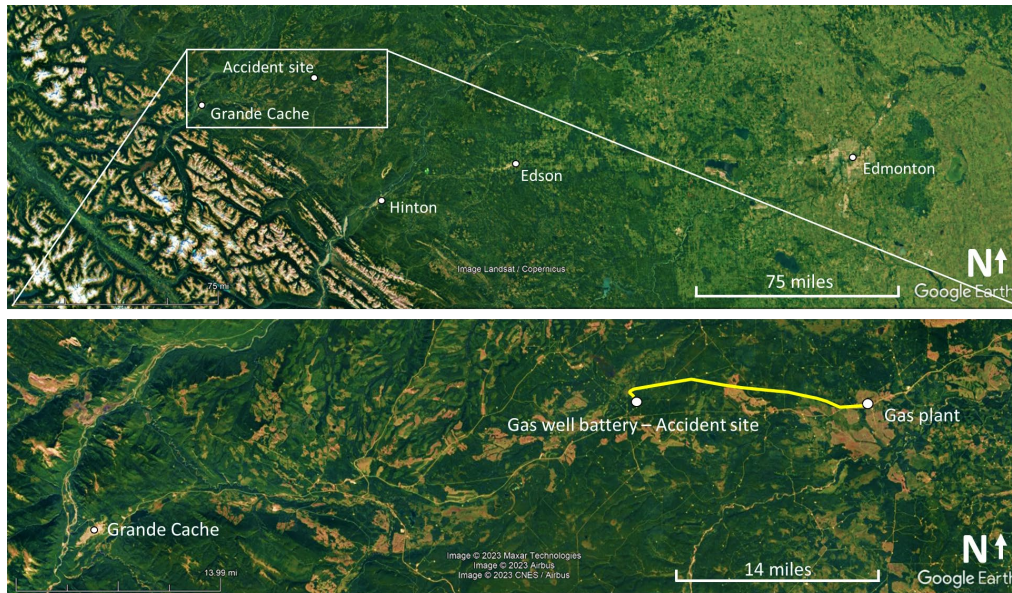
Figure 1. Map showing the accident site (top image), with a zoomed-in view showing the helicopter's flight path (bottom image) (Source of both images: Google Earth, with TSB annotations)
