MARINE INVESTIGATION REPORT

M02N0007

FIRE AND SINKING

OF THE SHRIMP FACTORY FREEZER TRAWLER *KATSHESHUK*
BELLE ISLE, NEWFOUNDLAND AND LABRADOR 76 NM ENE

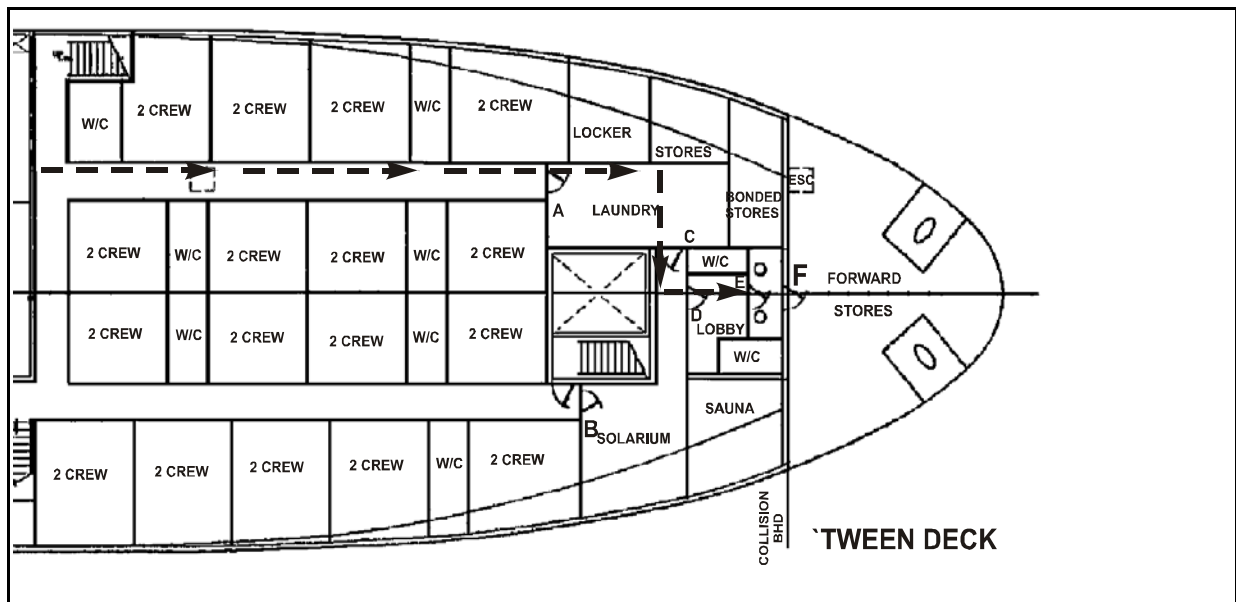
A fire party was assembled in the after cross-alleyway area of the 'tween deck accommodation. The fire party consisted of a fire lead wearing only coveralls and a self-contained breathing apparatus (SCBA) and others without SCBAs as a hose party. After a short delay to charge the fire main, the fire party proceeded up the port side alleyway and through the open door A (see Figure 3a) to the laundry room. Leaving the rest of the hose party in the laundry room, the fire lead proceeded into the solarium through door C, latching it open on the way. The fire lead then opened door D and entered a small foyer where he was met by a wall of smoke. On opening either door E or F⁴, he was met with heat and flame and immediately opened up his hose in a straight stream pattern. He was only able to direct water on the fire for a few seconds before the rest of his fire party (with no SCBA) called for him to pull back. The fire lead, by now running low on air, dropped the hose in the laundry room and retreated to the cross-alleyway area leaving some doors in the open position.

While up forward and unknown to the first fire party, a second fire party was being assembled in the starboard alleyway (see Figure 3b). This team consisted of a fire lead wearing jeans, a short sleeve shirt and a SCBA accompanied by a hose party. As the first fire party was pulling back, the second fire party opened door B leading to the solarium and the fire lead felt some heat. He introduced water into the solarium for about a minute before deciding to pull back to get a safety line. On the second trip forward, the fire lead made it to door D and when he opened it, a white flame shot out over his head and hit the deckhead. He opened up his hose at the fire, but was quickly forced back by debris falling from the deckhead. The second fire party then retreated to the after cross-alleyway also leaving some doors in the open position.

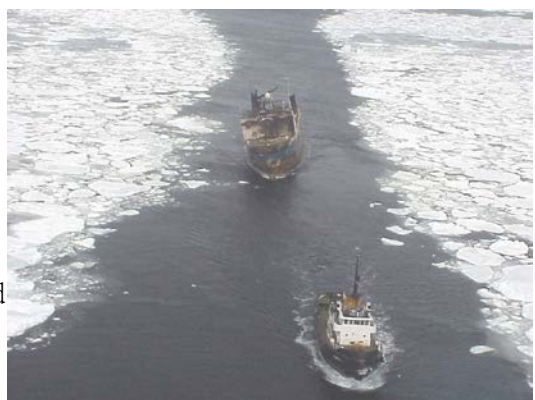
The owners of the *Katsheshuk* hired the tug *Atlantic Maple* to tow the vessel to port. By the time the tug arrived on the scene, the now derelict vessel had drifted approximately 168 nautical miles to the south. On the morning of 26 March 2002 (see Photo 4), the *Atlantic Maple* escorted by the CCGS *Henry Larsen* took the *Katsheshuk* under tow. The original plan was to tow the vessel directly to St. John's, Newfoundland and Labrador, but due to high winds, the tug and tow were forced to seek shelter in Trinity Bay and later Conception Bay.
