MARINE INVESTIGATION REPORT

M16C0005

Grounding

Container vessel *MSC Monica*

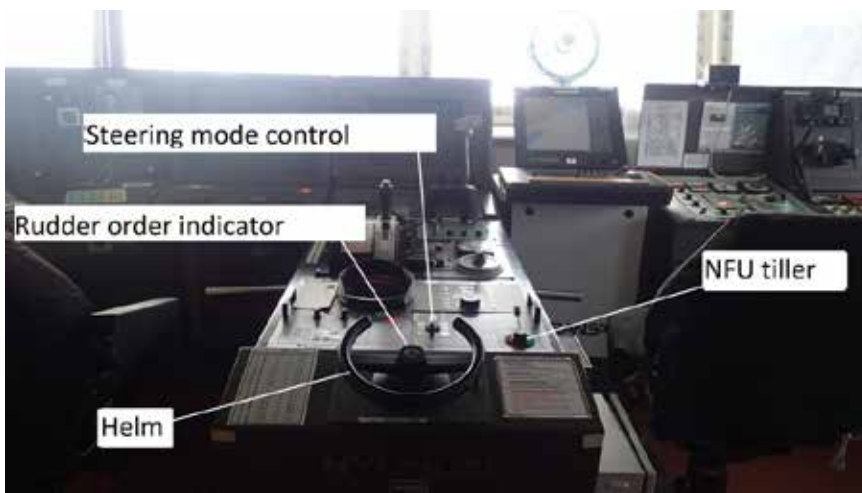
Figure 2. Conning station

On the *MSC Monica*, the helm at the conning station on the bridge main console is used to steer when the vessel is in follow-up mode. A rudder order indicator in front of the helm (Figure 2) displays the order input to the steering gear. A ceiling-mounted, 3-face rudder

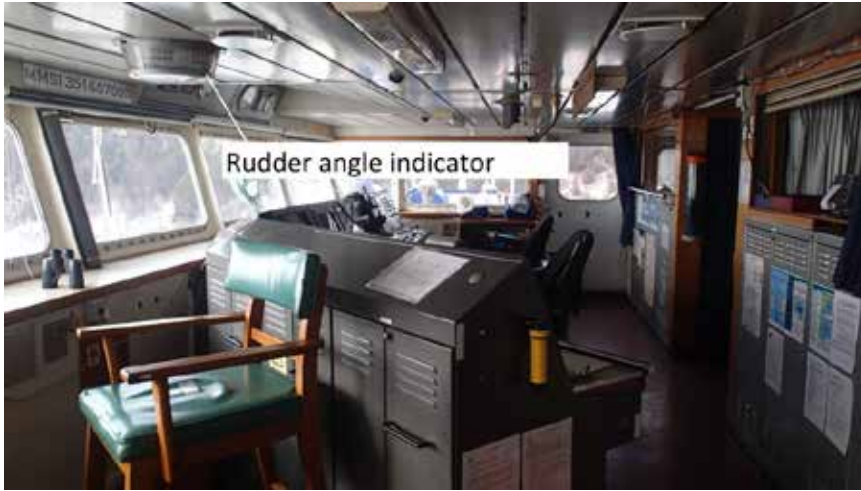
Figure 3. Rudder angle indicator

angle indicator is installed on the centreline of the navigation bridge, showing the actual position of the rudder (Figure 3).

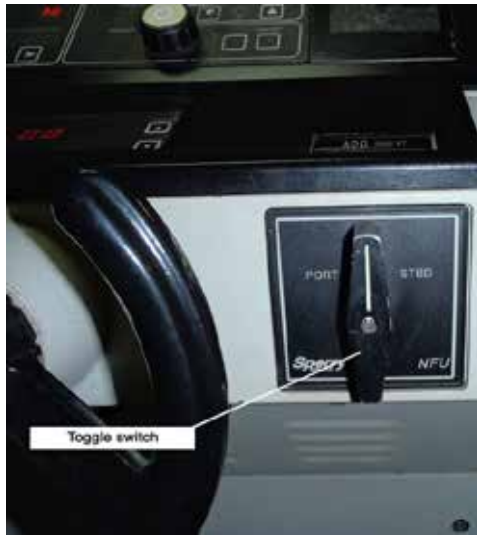
Figure 4. Non-follow-up tiller – Toggle switch

On the *MSC Monica*, the NFU tiller is located in front of the helm, on the starboard side of the steering gear control panel. At the time of the occurrence, it consisted of a lever with the longer end pointing toward the bow of the vessel. At the base of the lever was a translucent plastic disc with one half coloured green and the other red. At the top, across the two halves where they met, was a strip of light that backlit that portion of the base, 25 percent of its total circumference (Figure 6).
