MARINE INVESTIGATION REPORT

M17C0232

Person overboard and subsequent loss of life

General cargo vessel *Amazoneborg*

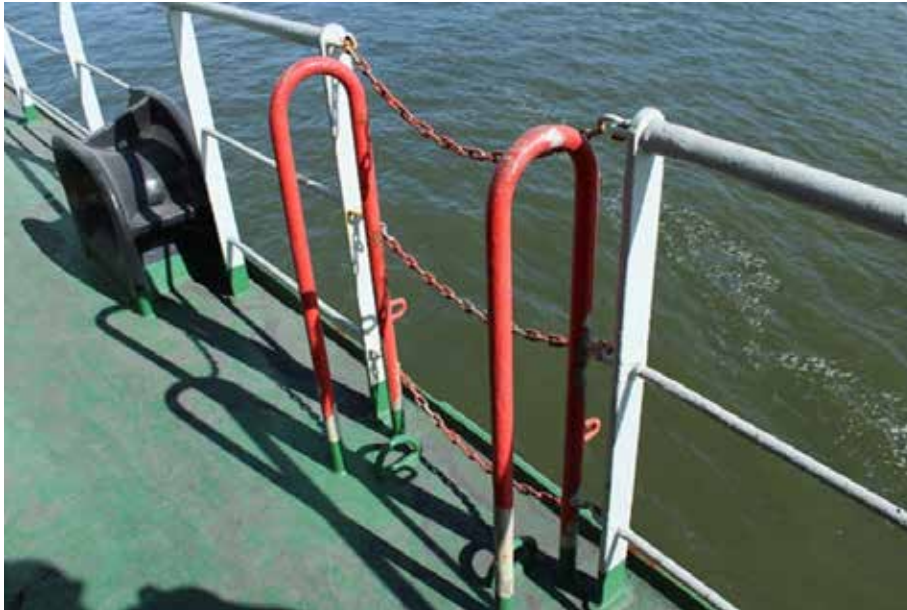
Figure 4. Pilot gateway on board the *Amazoneborg*

In accordance with SOLAS, the *Amazoneborg's* guardrail is equipped with 6 gateways at various locations for pilot and embarkation ladders (Figure 4). Each gateway is fitted with a removable chain or gate and handhold stanchions. The handhold stanchions and the securing strong points are permanently welded to the main deck. They ensure a safe means of transferring between the ladder and the deck. None of these gateways are aligned with or near the vessel's amidships draft marks.
