# Marine Transportation Safety Investigation Report M18P0144

## UNCONTROLLED FALL OF RESCUE BOAT

*Spirit of Vancouver Island* rescue boat No. 3  
Swartz Bay, Vancouver Island, British Columbia  
19 June 2018

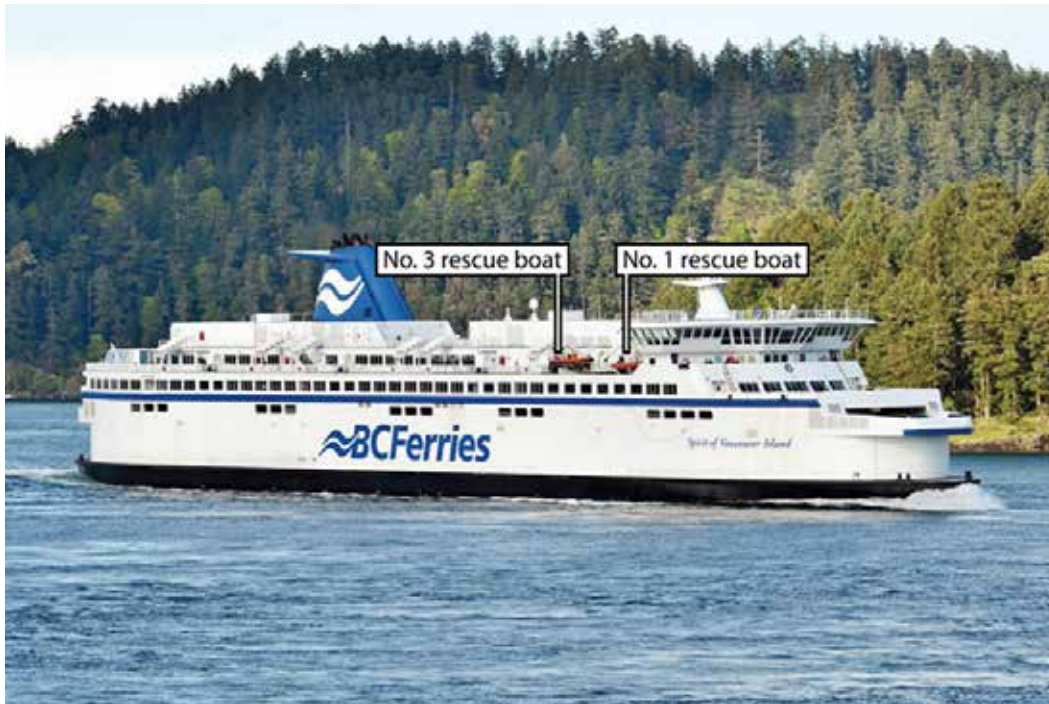
Figure 1. The Spirit of Vancouver Island and its starboard-side rescue boats (Source: British Columbia Ferry Services Inc., with TSB annotations)

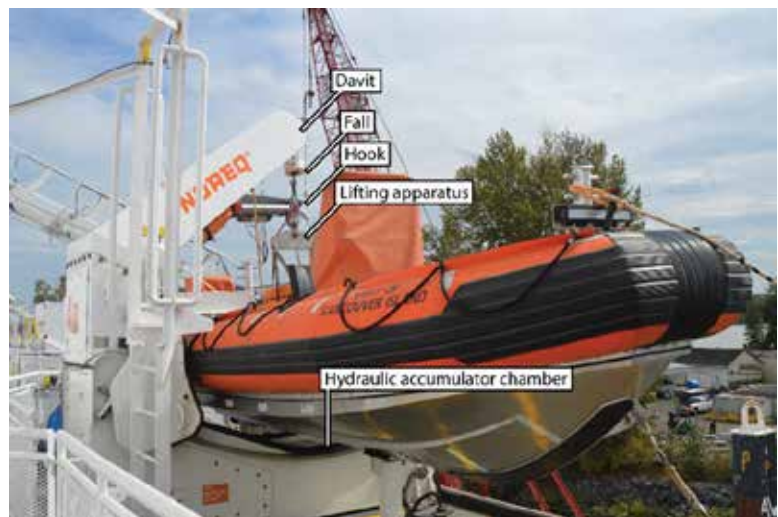
Figure 2. A rescue boat similar to the occurrence rescue boat, with the same type of davit
