## **MARINE TRANSPORTATION SAFETY INVESTIGATION REPORT M19A0025**

### **SINKING AND LOSS OF LIFE**

Workboat *Captain Jim*

29 January 2019

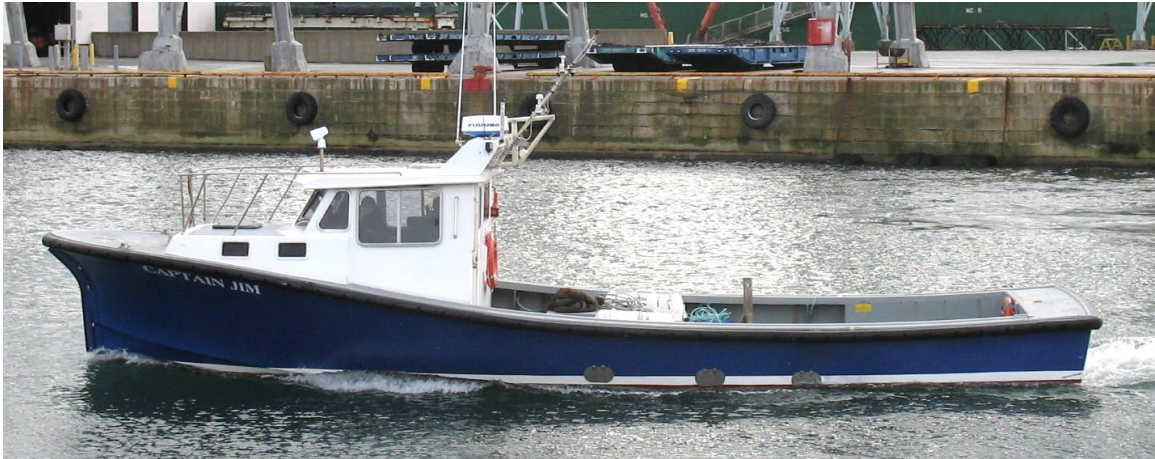
The *Captain Jim* was purchased by RMI Marine in 2004 for use as a multi-purpose workboat and was operated primarily as a passenger vessel for transporting people to work sites (Figure 1). The wheelhouse was equipped with electronic equipment consisting of 2 very high frequency (VHF) radiotelephones, a radar, a chart plotter and a global positioning system. There were floodlights and 2 life rafts on top of the wheelhouse at the time of the occurrence.

Figure 1. The Captain Jim (Source: Mac Mackay at Tugfax)

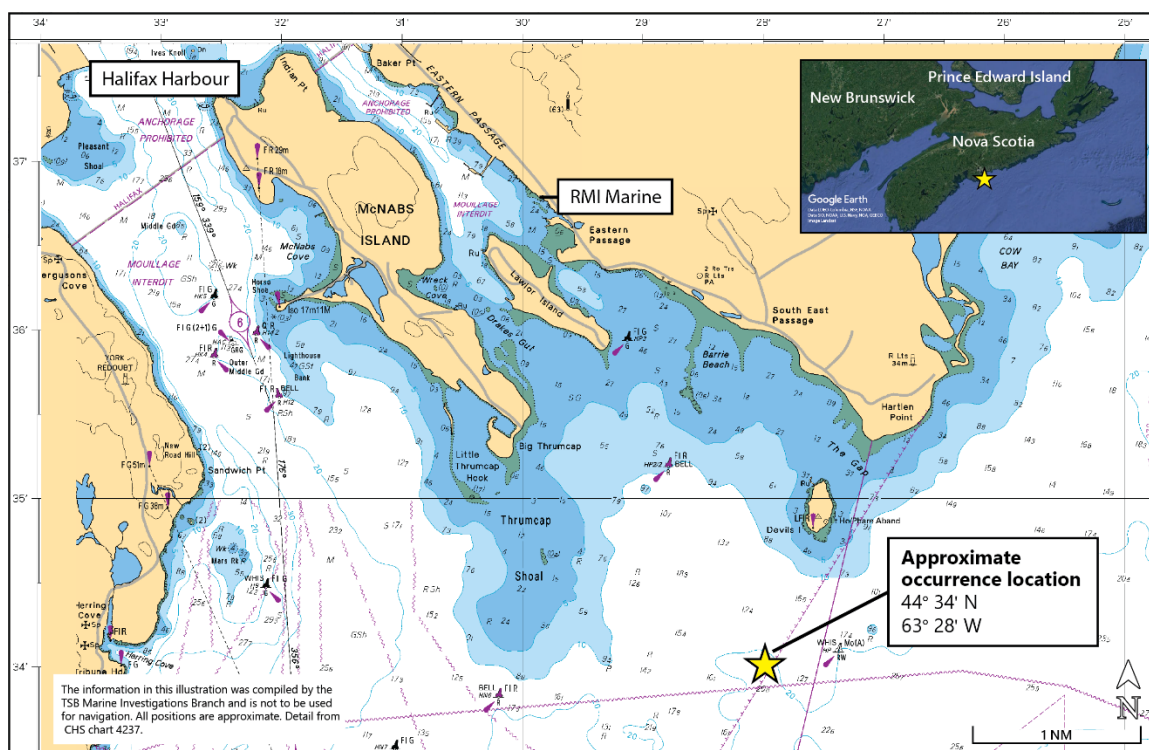
At 0232, JRCC Halifax called the master's cellphone, and the master informed JRCC of the situation. In the darkness, the master and passenger searched for the deckhand in the water without success. At 0234, MCTS Halifax lost the *Captain Jim* on radar as the vessel sank below the water's surface (Figure 5). At 0315, the Halifax Harbour pilot boat rescued the master and passenger from the life raft and transported them to Halifax, where they received medical attention. Later that day, at 1105, divers entered the wheelhouse of the sunken vessel, where they found the body of the deckhand and recovered it at approximately 1200. The vessel was recovered on 07 February.

Figure 5. Area of the occurrence (Source: Canadian Hydrographic Service Chart No. 4237, with TSB annotations)
