## **MARINE TRANSPORTATION SAFETY INVESTIGATION REPORT M19P0020**

### **STRIKING OF BERTH AND SHORE GANTRY CRANE**

#### **CONTAINER VESSEL *EVER SUMMIT***

Vanterm, Port of Vancouver  
Vancouver, British Columbia  
28 January 2019

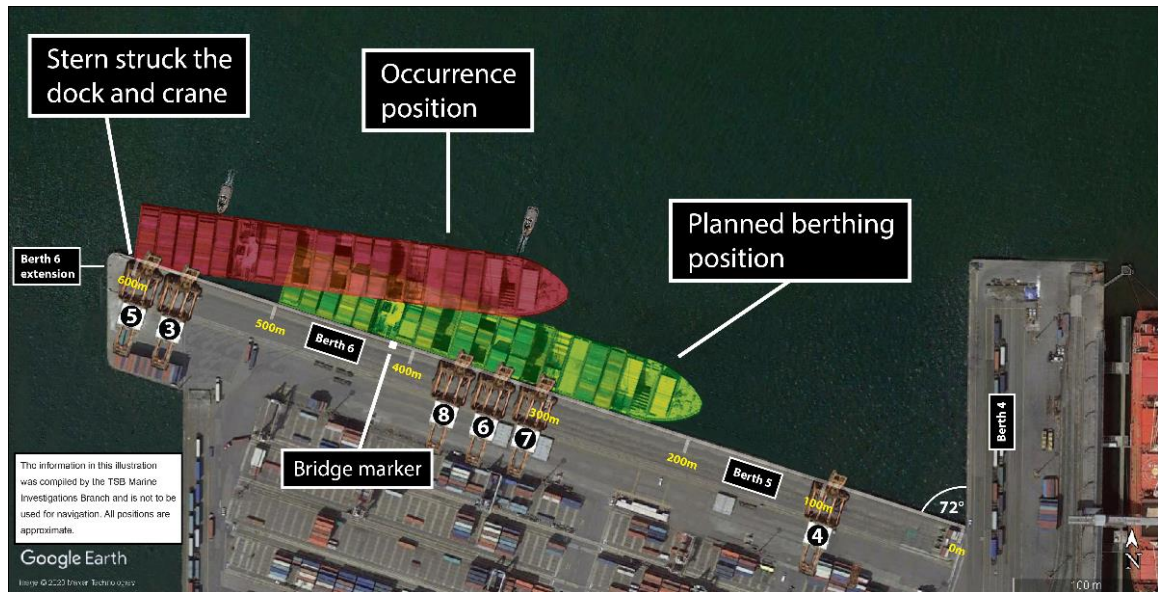
Figure 3. Vanterm berth layout (Source: Google Earth, with TSB annotations)

For large container vessels, Vanterm has a 619 m berth face made up of berths 5 and 6 combined (Figure 3). The original berth plans for the terminal indicate that the terminal was designed to have 2 separate berths.<sup>29</sup> However, the increase in length of container vessels currently berthing at Vanterm has effectively reduced the terminal to a one berth operation, with the vessels being docked somewhere between berths 5 and 6. The water depth alongside is approximately 15.5 m. The apron extends 7.08 m above chart datum. At the mean high tide point, the distance between the top of the apron and the water level is approximately 2.2 m.

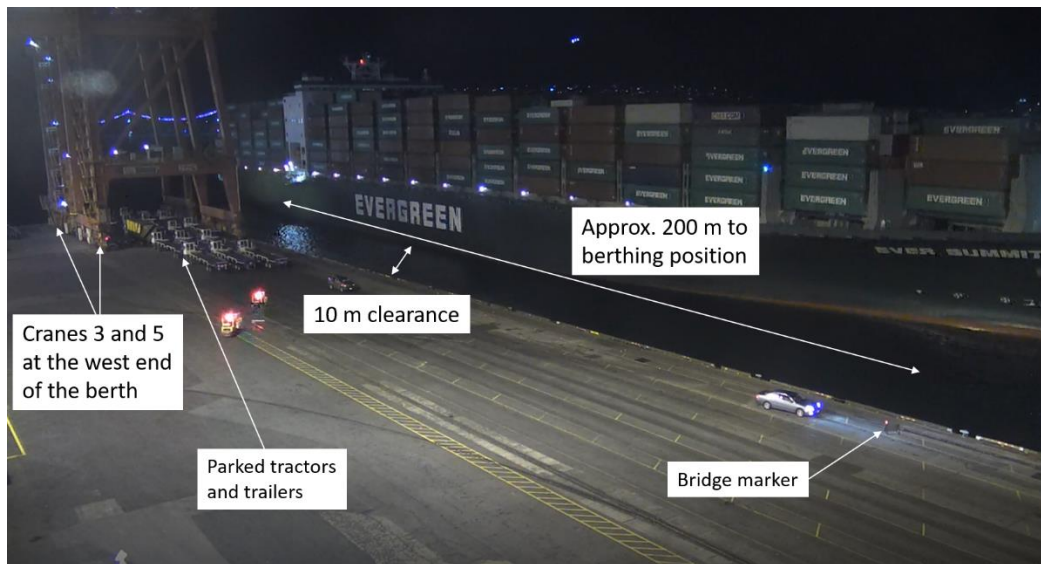
Figure 4. Capture from the closed-circuit television footage of the *Ever Summit* approaching Vanterm (Source: GCT Canada, with TSB annotations)

The pilot and tugs were all using VHF channel 17 for communications. At approximately 0343, after experiencing some disturbance on this channel, they switched over to another working channel. At this time, the *Ever Summit* was approaching the berth on a course that was nearly parallel to it and approximately 10 m off (Figure 4).

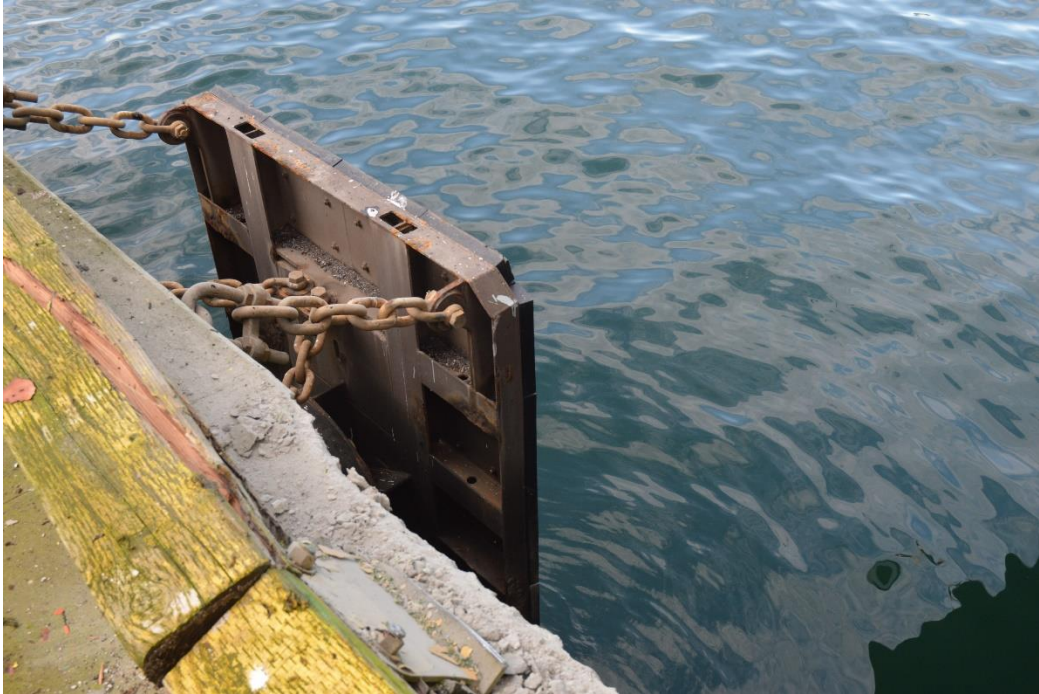
Figure 9. Cone fenders on Vanterm berth 6 extension (Source: TSB)

The cylindrical fenders do not have a means of reducing sliding friction. Large friction forces can develop as the rubber fender is compressed between the vessel hull and the concrete berth face, resulting in damage to the anchoring chains or plates. The fenders are known to the pilots as being "sticky," meaning that the vessel's hull does not slide easily along the fenders, but rather "sticks" on them, which can make berthing more difficult.

The fender system installed on the berth 6 extension differed from the fenders on berth 5 and the original part of berth 6. The fenders on the berth extension are cone fenders fitted with fender panels and support chains (Figure 9). The energy absorption capacity of these fenders is rated at 799 kN-m.

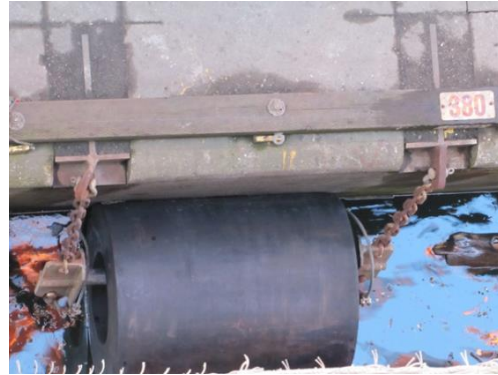
Figure 10. Fender at Vanterm (Source: TSB)

The review also identified that the existing cylinder fender system was inappropriate for the size of container vessels that dock at the berth. The energy absorption capacity of the fenders was significantly less than the required energy absorption for the maximum design vessel<sup>30</sup> (1662 kN-m). The fender stand-off distance<sup>31</sup> was inadequate, and the fender spacing was too far apart considering the size of the fenders and the heavy loads placed on them.

Figure 10 and Figure 11 show examples of the fenders at Vanterm and at Deltaport 3, respectively.

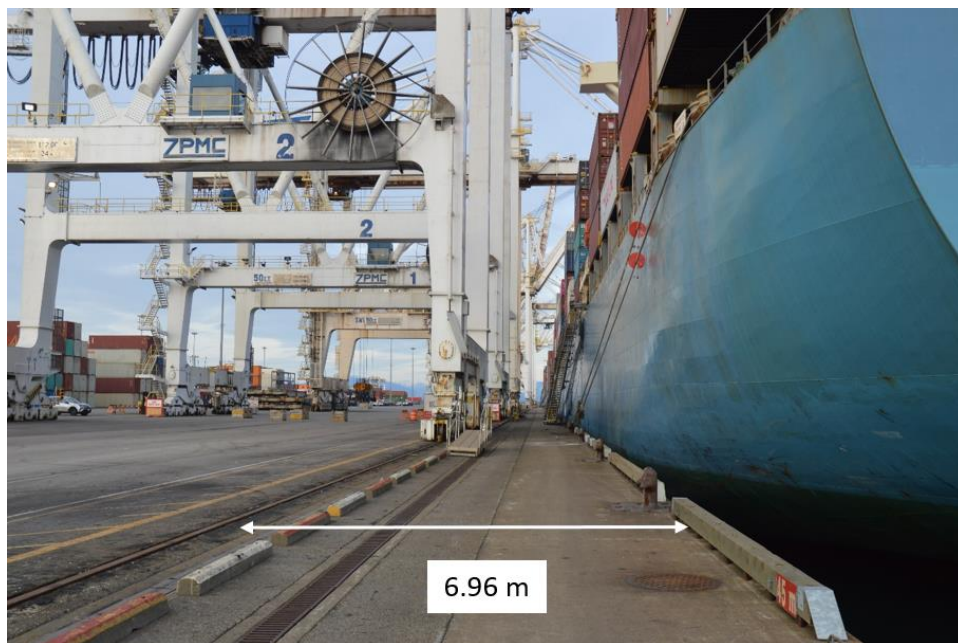
Figure 13. Distance between the berth line and the crane rail at Deltaport 3 (Source: TSB)

Deltaport 3 was designed for a maximum approach angle of  $5^{\circ}$  at a velocity of 12.5 cm/s. The bollards are rated for 125 tonnes safe working load, with 200 tonnes safe working load bollards at the ends of the berth. The distance from the waterside crane rail to the berth line is approximately 6.96 m at Deltaport 3, whereas the distance from the crane rail to the berth line at Vanterm is 2.13 m (Figure 12 and Figure 13).

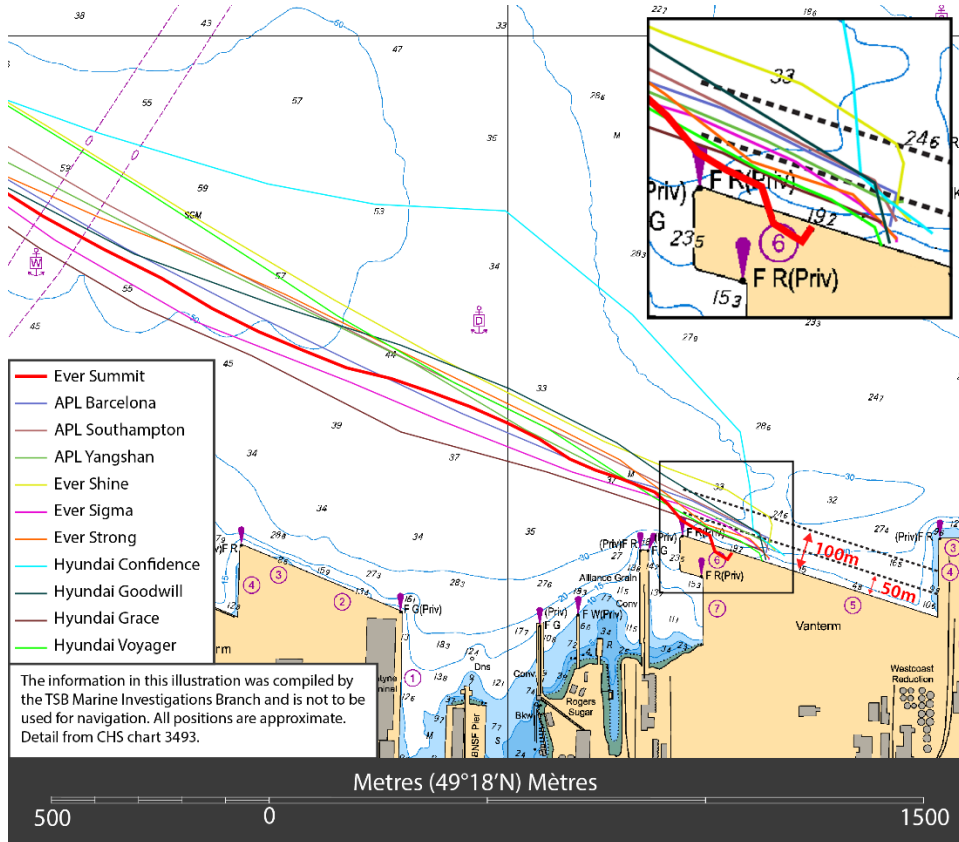
Figure 16. Tracks of vessels berthing at Vanterm berth 6 in January 2019 (Source: Canadian Hydrographic Service, with TSB annotations)

of 50 m or less while approaching the berth. On approach, the *Ever Summit* was the closest of the 4 to the berth.
