MARINE TRANSPORTATION SAFETY INVESTIGATION REPORT M20P0353

ACCIDENTAL RELEASE OF FREE-FALL LIFEBOAT

Bulk carrier *Blue Bosporus*
English Bay, British Columbia
01 December 2020

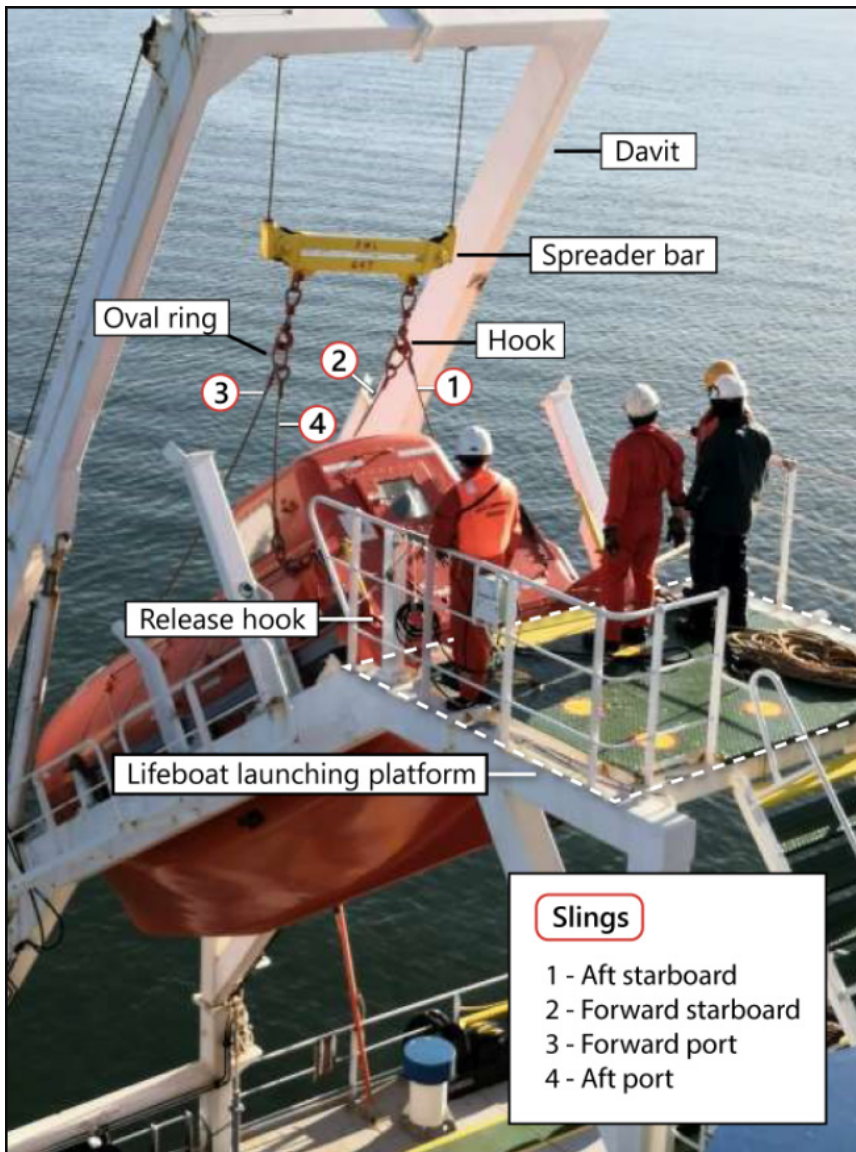
Figure 2. Free-fall lifeboat attached to the davit by slings (Source: Apollonia Lines S.A., with TSB annotations)

Before lowering the lifeboat using the davit, the lifeboat must first be attached to the davit using 4 wire rope slings (slings) (Figure 2). The lower end of each sling is attached to the lifeboat with a shackle. The upper end of each sling is permanently coupled to an oval ring; the oval ring is then connected to a hook on the spreader bar. The investigation could not determine how or where the slings were stowed when not in use.

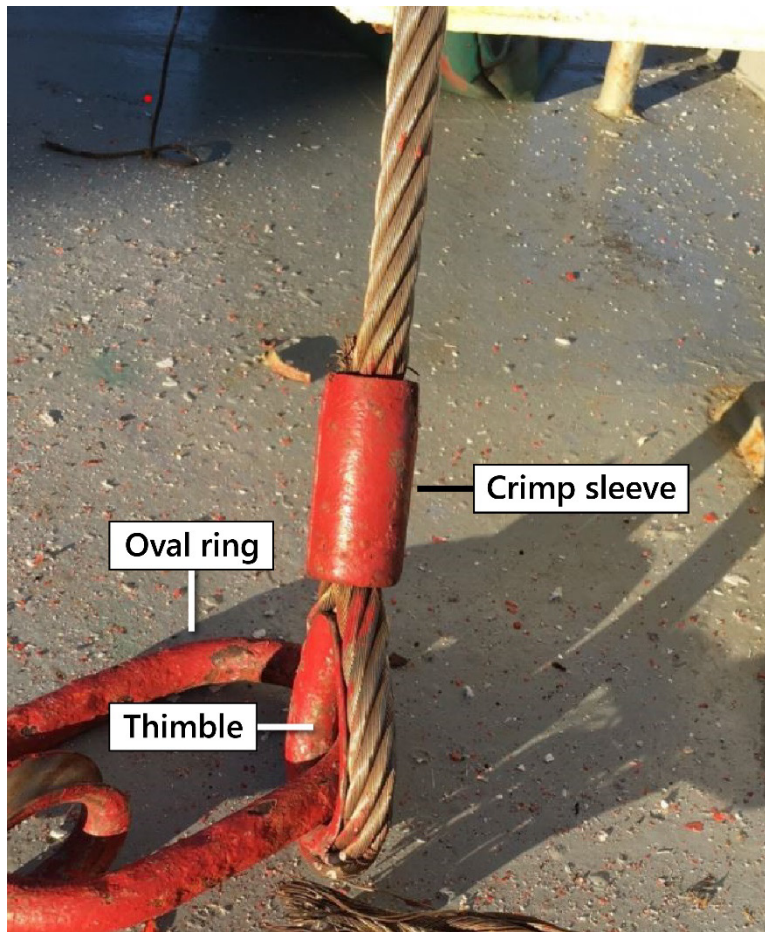
The slings in use at the time of the occurrence consisted of wire ropes with an eye at either end. The eye was formed by threading the wire rope around a thimble and then securing the wire in place using a crimp sleeve (Figure 3). A crimp sleeve is a type of mechanical splice that can be crimped using a hydraulic machine or hand tools. In this case, the crimp sleeves were crimped using a hydraulic machine during manufacture.

Figure 3. Eye of sling with wire rope threaded around thimble and secured with crimp sleeve (Source: TSB)

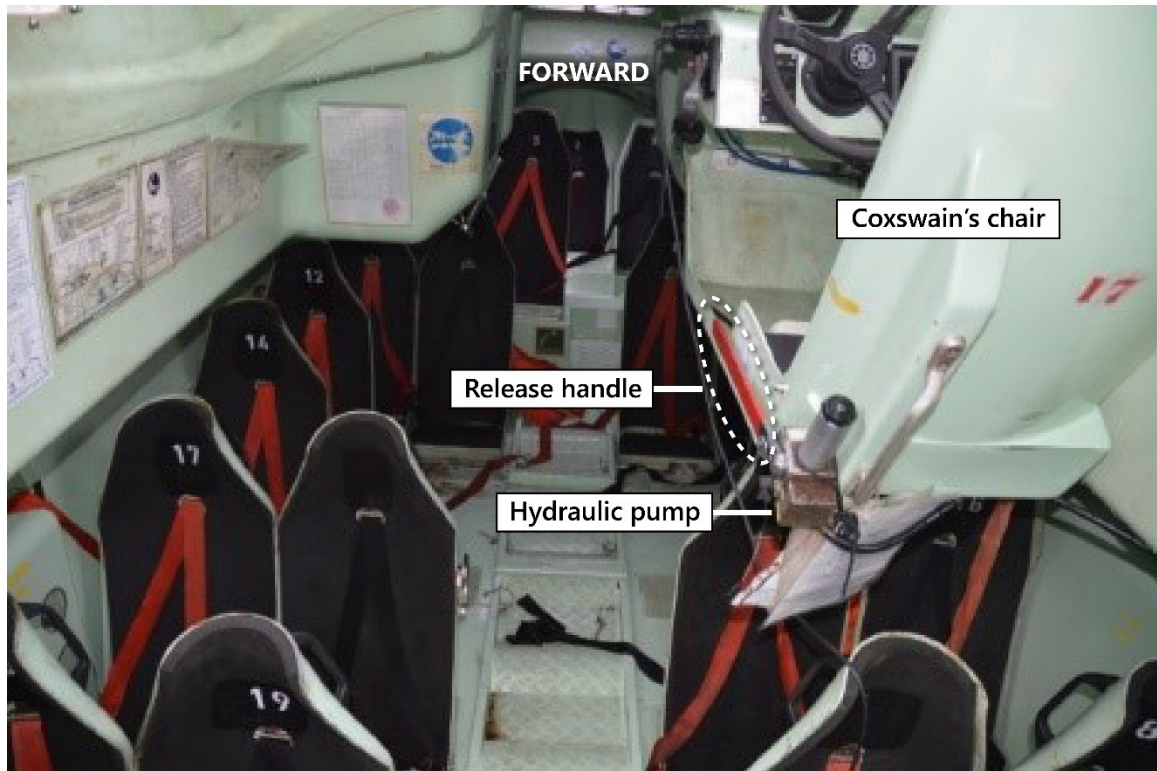
The third officer entered the lifeboat and stood beside the coxswain's chair facing toward the bow of the lifeboat. He then moved the release handle up and down 8 to 10 times in order to build up the hydraulic pressure needed to unlatch the release hook (Figure 5).

Figure 5. View inside lifeboat showing release handle beside coxswain's chair (Source: TSB)
