## Marine Occurrence Report

### Uncontrolled Fall of a Lifeboat

on the General Cargo "IRAN SALAM"  
Port of Montreal, Quebec  
29 November 1993

Report Number M93L0006

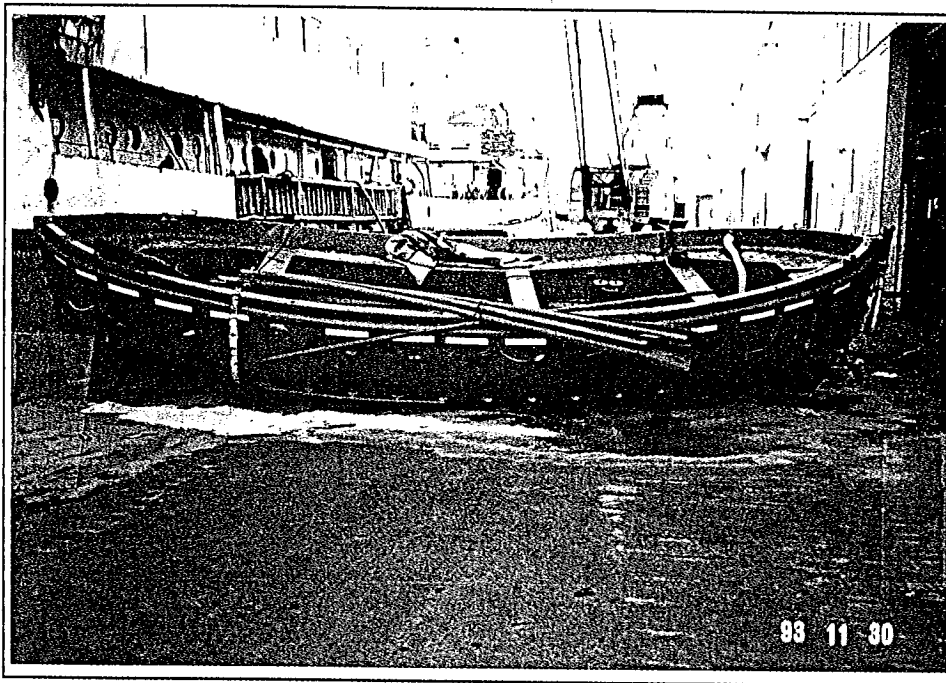
Port side of the lifeboat.

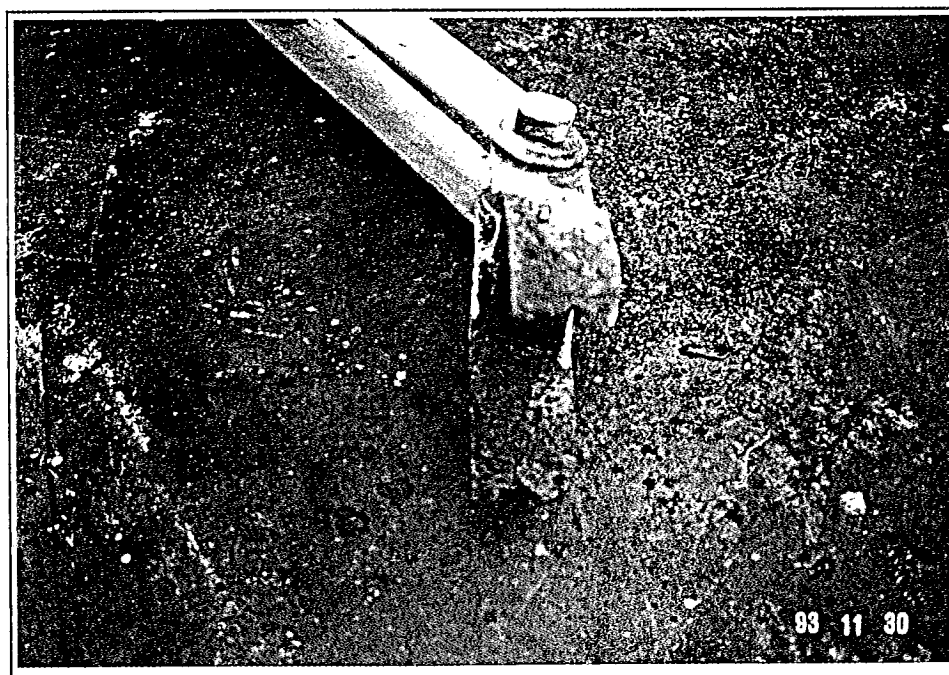
The lifting hook connections on the starboard lifeboat were in an advanced state of corrosion, especially the connection of the after lifting hook which had deteriorated further than the forward connection.

It was determined that the forward connection was as much as 88 to 89 per cent deteriorated, and the after connection was deteriorated as much as 90 to 94 per cent. Such a considerable deterioration only could have developed over a period of several years. In addition, a post-occurrence examination of the connections revealed that the fractures were not fresh over their full width.

Connection of the after lifting hook of the lifeboat.
