## Marine Occurrence Report

### Sinking

of the Small Fishing Vessel "JU JU"  
Queen's Sound, British Columbia  
19 March 1993

Report Number M93W0003

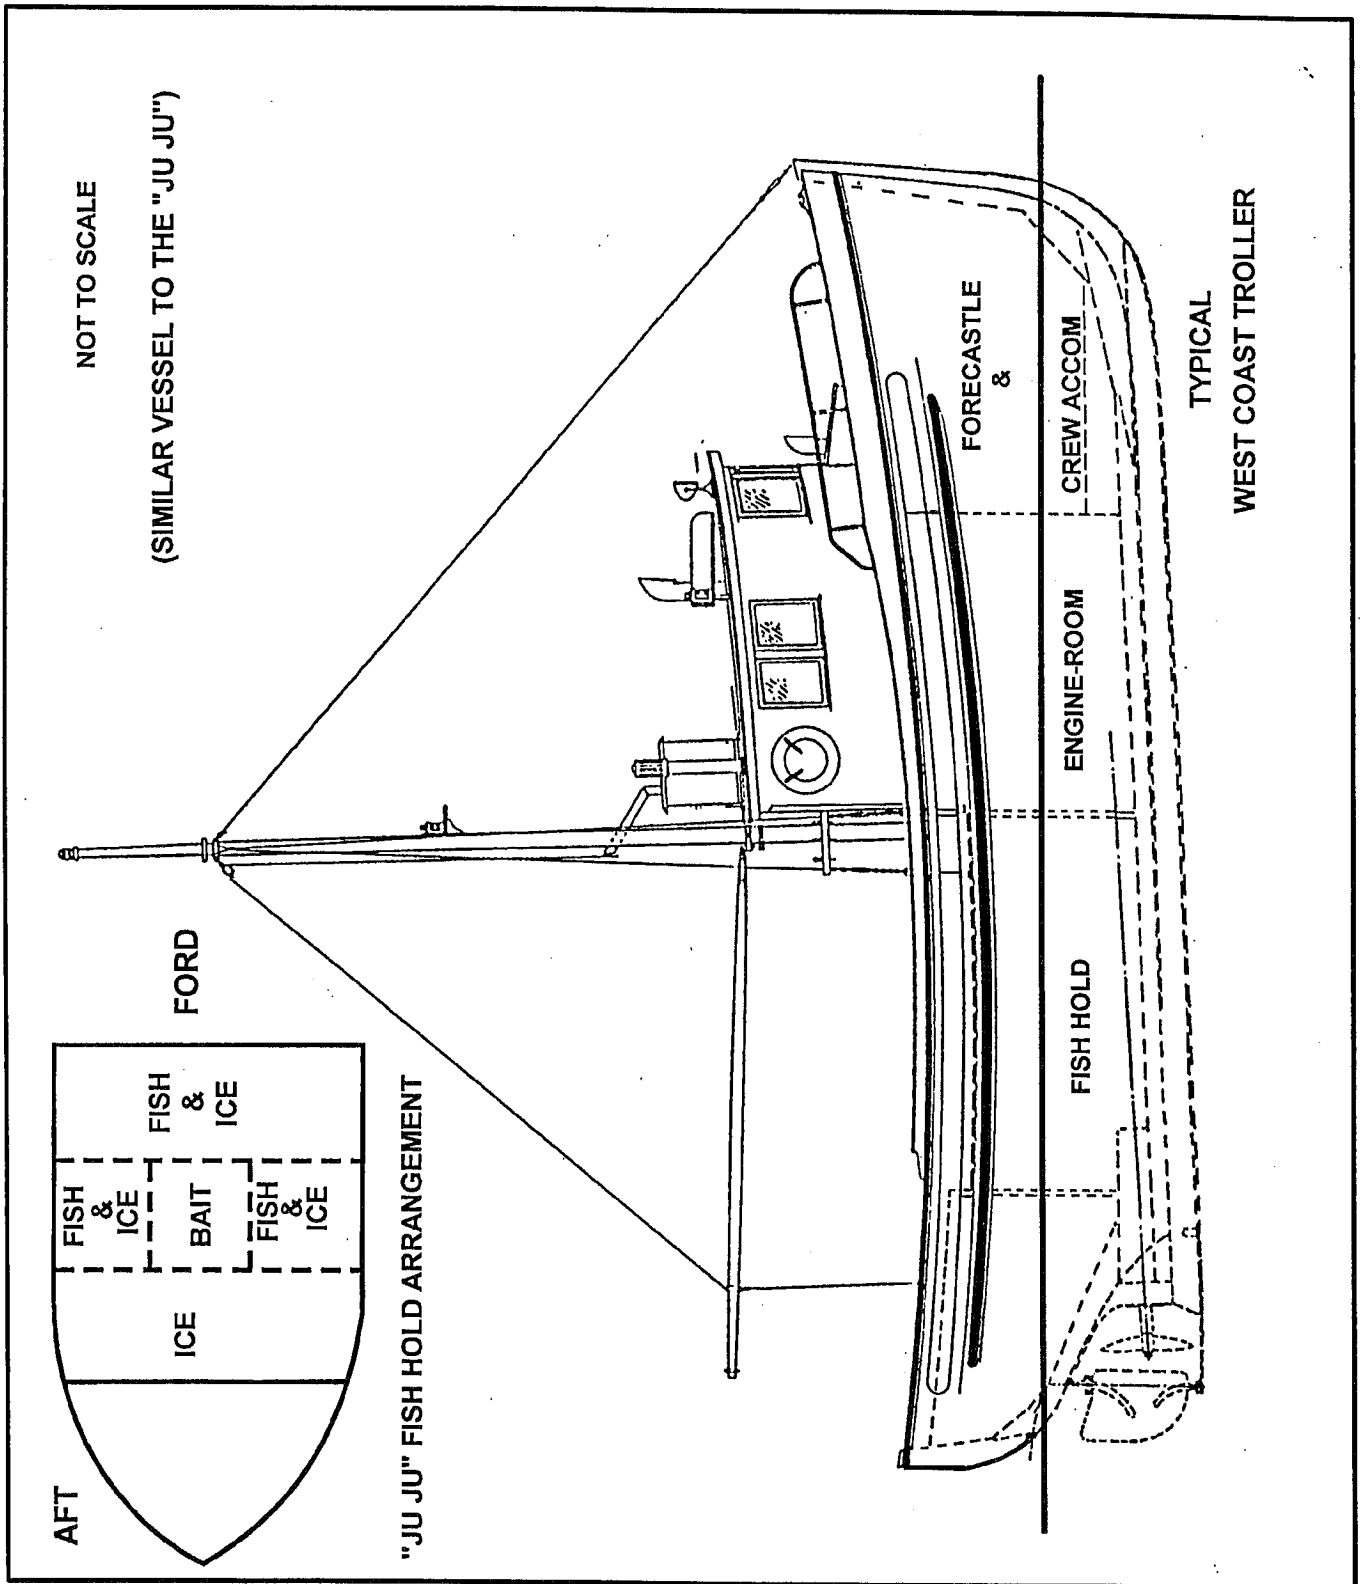
Appendix B - Sketch

The source of the water entry that caused the automatic pumps to activate in the lazaret, cockpit, and fish hold is not known. However, considering the short time taken for the large trim by the stern to develop after the longline was retrieved, it is apparent that the size of the opening that allowed the ingress of water was substantial and is consistent with a plank having sprung in the hull, below the waterline, in the vicinity of the lazaret and fish hold. This could have happened while the vessel pounded into the seas after the longline was retrieved. It should be noted that, with the exception of the small penetration on the after fish hold bulkhead for the steering gear cable to pass through, there were no other openings between the fish hold and the lazaret space.

The additional weight of shipped water below decks caused the vessel to settle deeper by the stern, thus reducing the freeboard aft. The accumulation of water on deck from shipped seas would have become progressively worse, causing the vessel to settle still deeper, thus covering the freeing ports.

broadside to wind and waves, continuous downflooding into the engine-room and forecabin eventually caused the sinking.

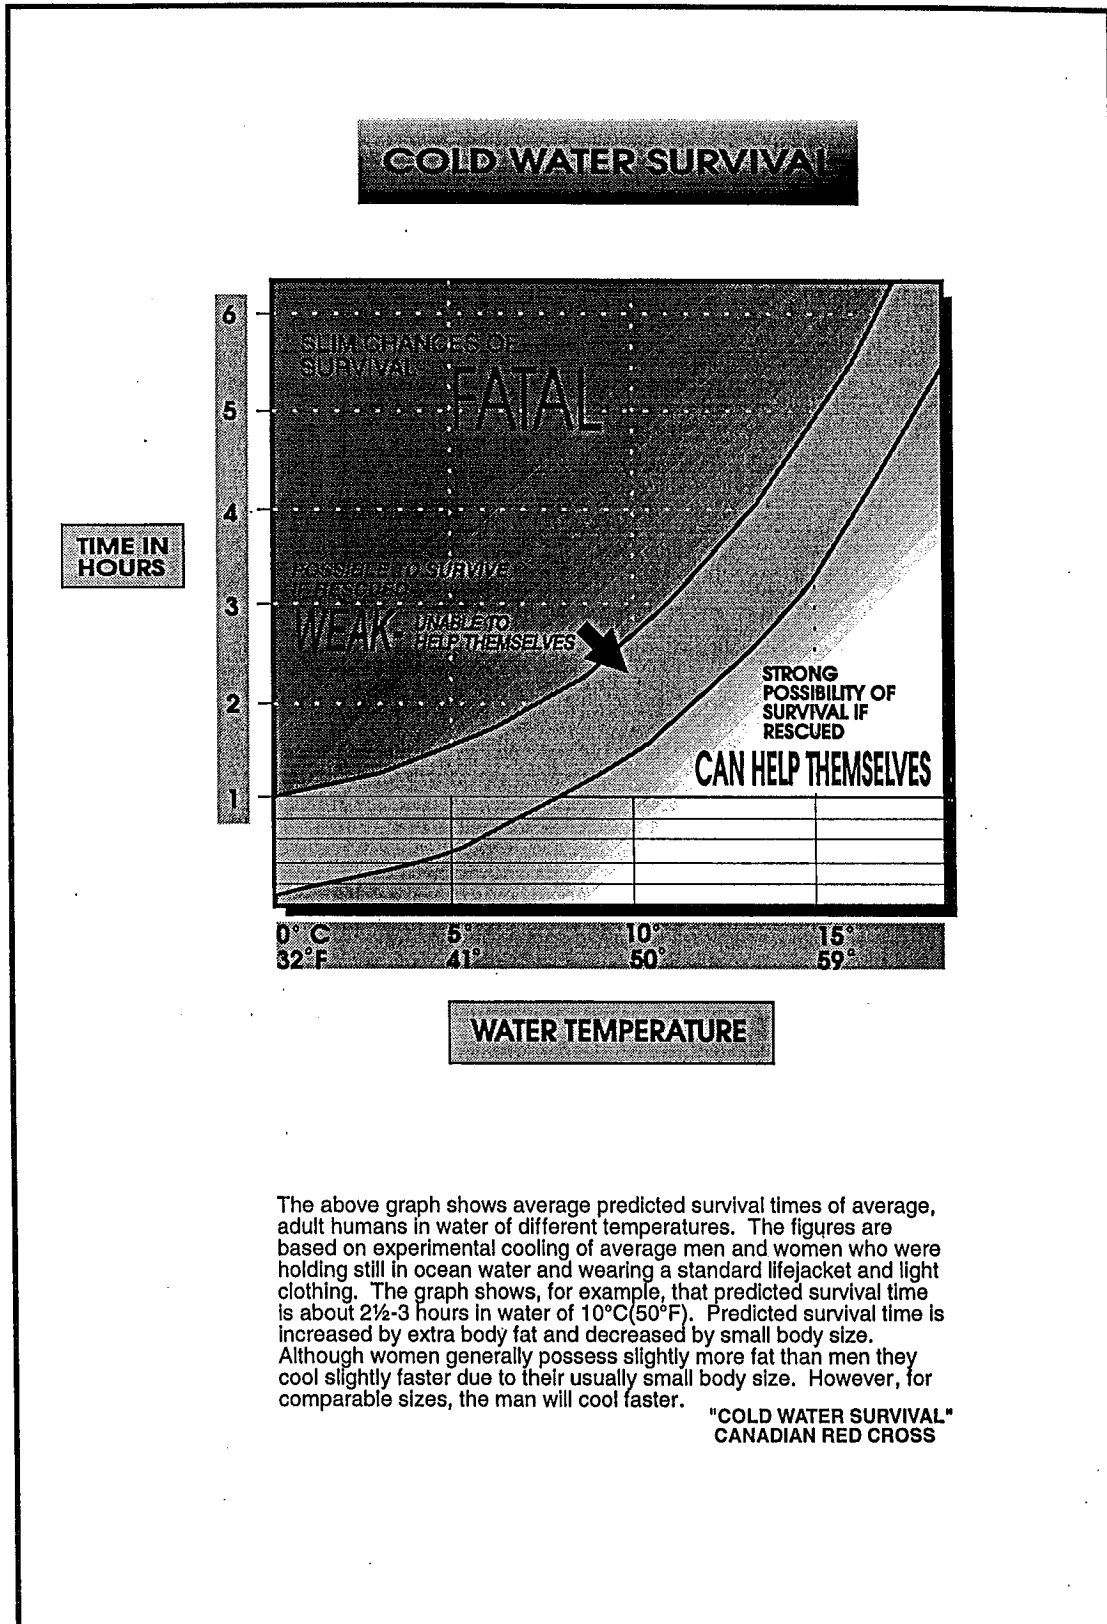
# Appendix C - Cold Water Survival Graph

The Canadian Red Cross has a graph of average predicted survival times for average adults wearing a standard lifejacket and light clothing in sea water. The graph indicates that, in sea water of 7°C, which was the water temperature in this case, the survival time of such a person is approximately two hours.
