Marine Occurrence Report

Multiple Capsizings

Group of Chartered Sea Kayaks
Laskeek Bay, Queen Charlotte Islands,
British Columbia
30 July 1993

Report Number M93W0008

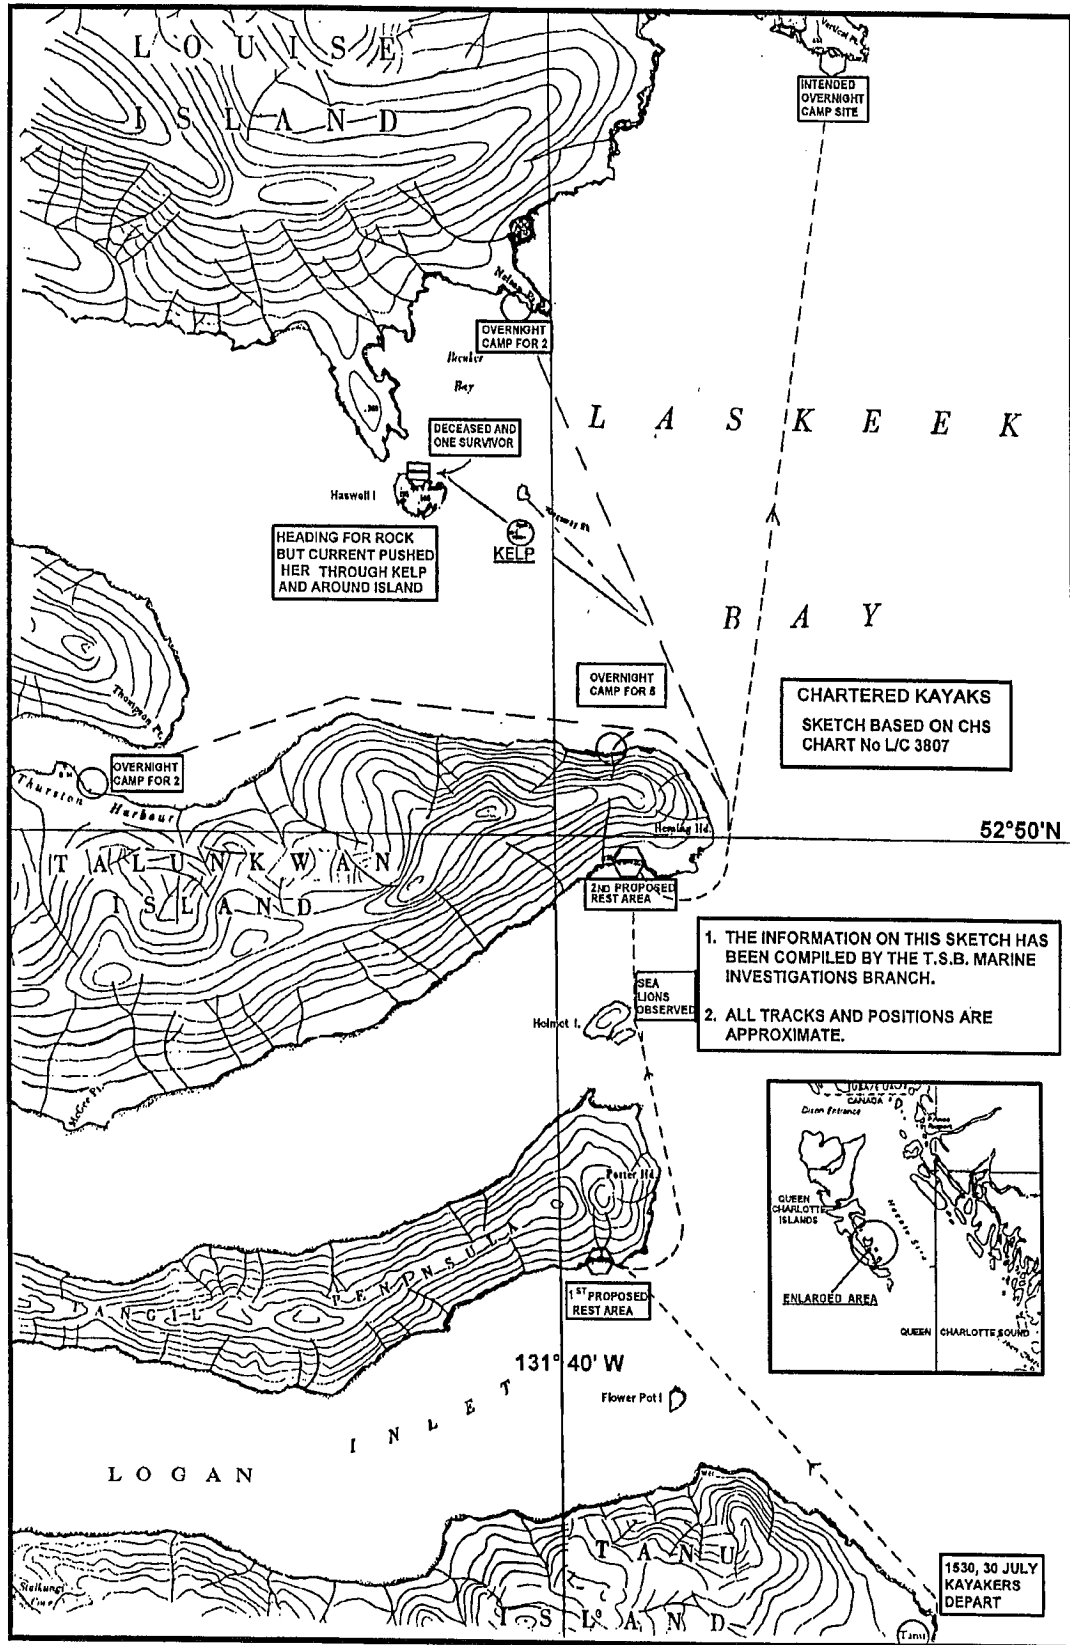
Appendix B - Sketch of the Occurrence Area

As the first group approached Heming Head and came out of the lee of Kunga Island, B.C., the wind and wave heights increased. The head guide found that the second rest area was also unusable because of the heavy waves breaking on the beach. He then decided to try to land on the north-west side of Heming Head.

By the time the first group reached Heming Head, several of the charterers were feeling anxious about their ability to handle a kayak in the prevailing conditions. The wind was increasing to about 20 knots and the waves were up to 3 m in height, with breaking crests. Both wind and waves were from the south-east. The waves were higher in the shoal area close by Heming Head.
