RAILWAY INVESTIGATION REPORT
R09Q0030

DERAILMENT

CANADIAN NATIONAL
YARD ASSIGNMENT YLUS-30
MILE 14.80, BRIDGE SUBDIVISION
LIMOILLOU YARD
QUÉBEC, QUEBEC
17 JULY 2009

Report Number R09Q0030

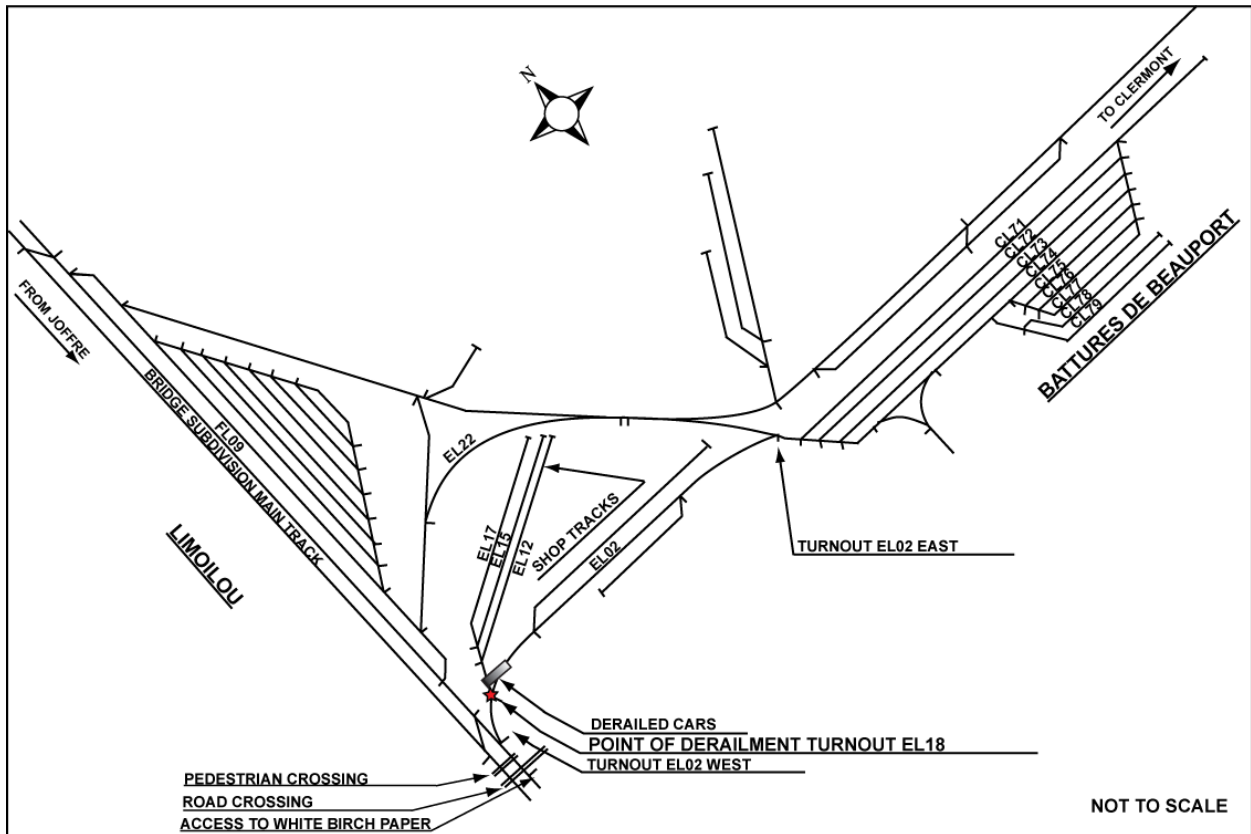
In the Limoilou Yard (see Figure 2), all movements (for example, trains, yard assignments and locomotive consists) are governed by Rule 105 of the *Canadian Rail Operating Rules* (CROR). CROR Rule 105 states in part that, unless otherwise provided by special instructions, movements using non-main track must operate at a speed that will allow them to stop within one-half the range of vision of rolling stock, and that must not exceed 15 mph. According to CN's Timetable 82 (the timetable), which came into effect 29 May 2009, this speed must not exceed 10 mph at the Limoilou Yard. In addition, CROR Rule 114 requires that movements be able to stop short of switches improperly lined.

CROR Rule 104 reads in part that, unless otherwise provided by special instructions, non-main-track switches, when equipped with a lock, must be lined and locked in the normal position after having been used. In addition, CN's document entitled *Informations générales triage Limoilou* (Limoilou Yard General Information) on the procedures related to the operation of movements in the yard states that, when yard operations are completed on shop tracks EL12, EL15 and EL17, the derail and the access switch for these tracks (EL18) must be reset to their normal position and locked. However, the timetable mentions that the switches at the Limoilou Yard can be left lined and locked in the reverse position.

Figure 2. Layout of Limoilou Yard
