**RAILWAY INVESTIGATION REPORT
R11T0161**

EMPLOYEE FATALITY

**VIA RAIL INC.
TRAIN VIA 051
MILE 314.4 KINGSTON SUBDIVISION
DURHAM JUNCTION, ONTARIO
14 JULY 2011**

Report Number R11T0161

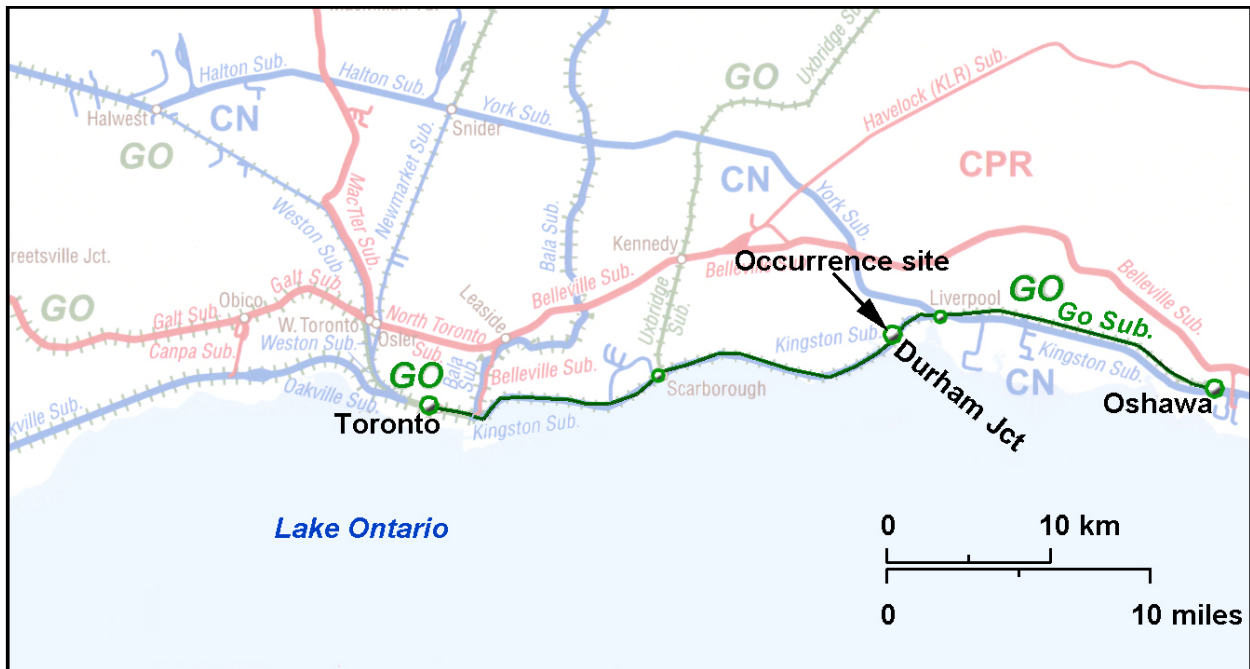
At approximately 1306, while travelling at 96 mph on the south track of the Kingston Subdivision near Durham Junction, VIA 51 rounded a 6000-foot long 1° left-hand curve. About 800 feet ahead (Mile 314.4), the crew noticed 2 CN Engineering Services (ES) employees, a senior track foreman and a trackman, working on the north track³. At 1306:20, VIA 51's bell and horn were sounded approaching the work location. Just before arriving at the work location, the crew made an emergency train brake application. The trackman, who was facing north east, reacted to the approach of the train as it came into sight, approximately 6 seconds before it reached the work site. He moved north, cleared the track and shouted at his co-worker to clear the track. The senior track foreman attempted to exit over the south track, moving into the path of the oncoming train. The senior track foreman was struck by VIA 51 and was fatally injured. The train crew made an emergency radio call to advise the rail traffic controller (RTC) of the accident and to request emergency medical assistance. VIA 51 came to a stop approximately 3440 feet west of the accident location (Figure 1).

Figure 1. Occurrence site (Source: Railway Association of Canada, *Canadian Railway Atlas*)
