**RAILWAY INVESTIGATION REPORT
R13E0142**

NON-MAIN-TRACK DERAILMENT

**CANADIAN NATIONAL
FREIGHT TRAIN M30151-18
MILE 57.25, EDSON SUBDIVISION
GAINFORD, ALBERTA
19 OCTOBER 2013**

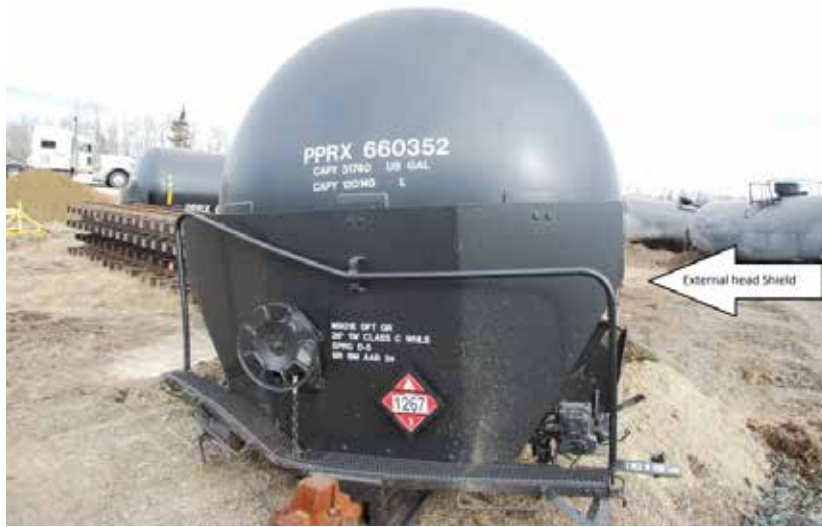
The 4 derailed cars transporting petroleum crude oil were designated as DOT 111A100W1 or DOT 111S100W1. The non-pressure tank cars were designed for general use. The tank thickness of the 111 tank cars was 7/16 inch. The 3 DOT 111A tank cars were equipped with external head shield protection (Photo 2). The DOT 111S tank car was equipped with the head shield incorporated into the design of the car (Photo 3).

Photo 2. External half head shield protection

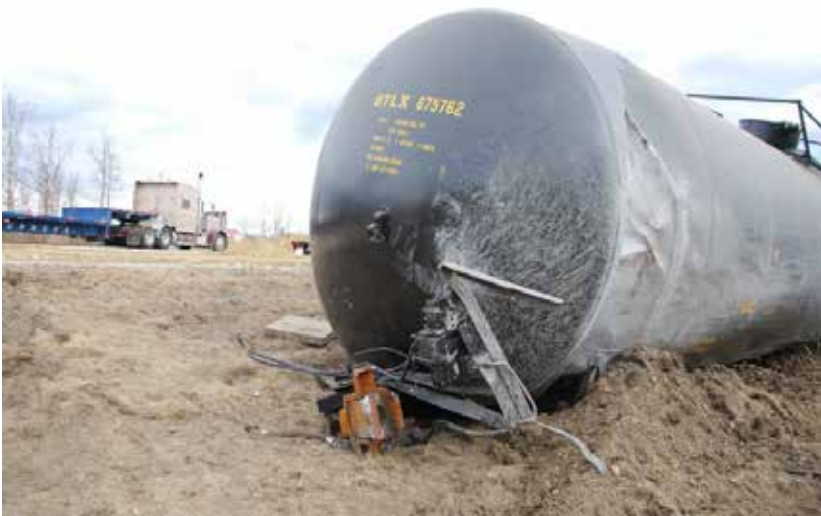
Photo 3. Head shield protection incorporated into tank head
