## **RAIL TRANSPORTATION SAFETY INVESTIGATION REPORT R18D0069**

### **MAIN-TRACK TRAIN DERAILMENT**

Canadian Pacific Railway  
Freight train 142-14  
Mile 36.6, Winchester Subdivision  
Saint-Polycarpe, Quebec  
16 July 2018

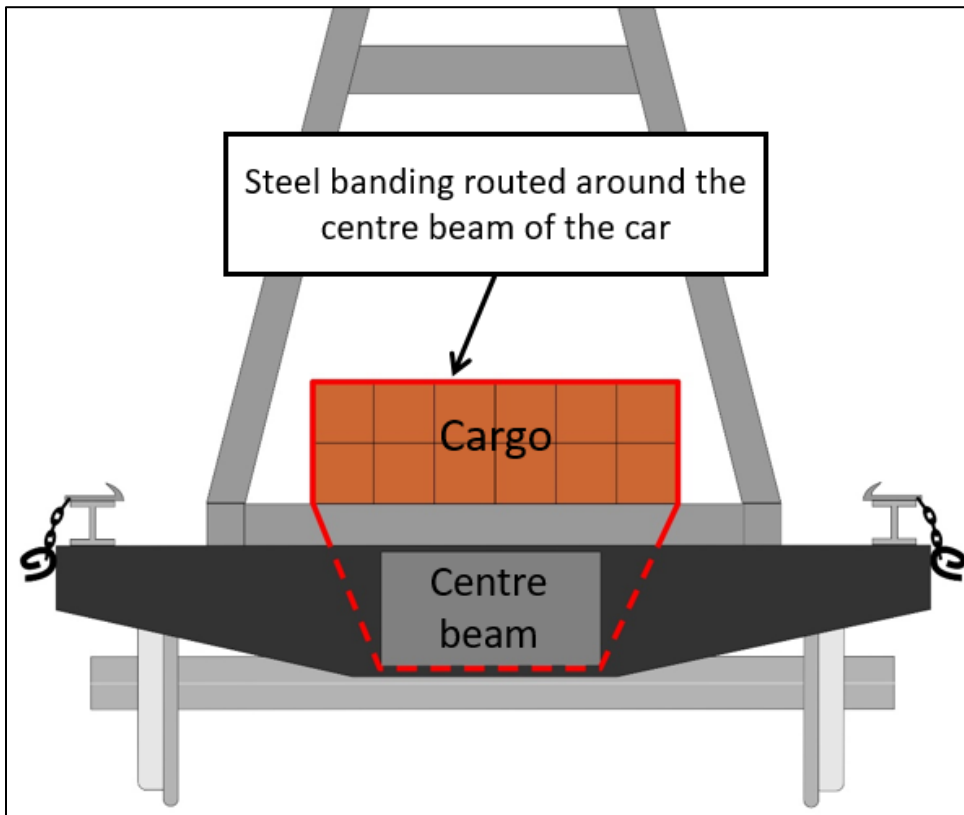
Figure 8. Securement of cargo under the A-frame (CP practice before May 2018)  
(Source: TSB)

- Track panels were secured to the A-frame using chains or cables.
- Material loaded on the car deck beneath the A-frame was secured using steel banding routed through the car deck and around the centre beam.
- When stock rails were transported, they were normally placed on and secured to the brackets on the side of the car using e-clips (Figure 8).
- If stock rails were loaded with other materials on the car deck, they were secured where they were placed.

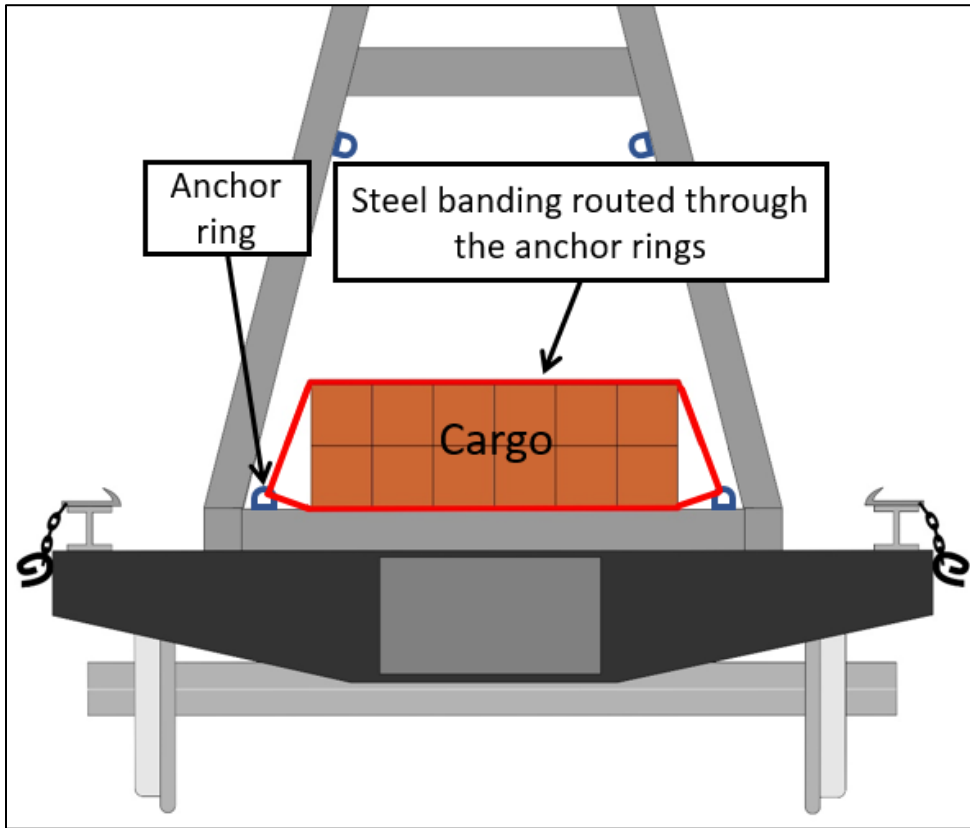
Figure 9. Securement of cargo under the A-frame (after May 2018, following the issuance of Circular RAC 12010) (Source: TSB)

In May 2018, following the issuance of Circular RAC 12010, CP personnel involved in the loading and securement of track panels and related material onto A-frame flat cars were verbally advised to use anchor rings when securing material beneath the A-frame. With the exception of the use of anchor rings, CP considered the securement method documented in Circular RAC 12010 to adequately reflect its existing long-standing practices. As a result, no specific analysis of the use of anchor rings was performed. No additional details, instructions, documentation, procedures, or training related to the new circular were provided to personnel. Consequently, personnel modified their securement practice related to cargo under the A-frame by routing the steel banding through the anchor rings instead of around the centre beam (Figure 9), and no chains were used.
