RAIL TRANSPORTATION SAFETY INVESTIGATION REPORT R18M0037

EMPLOYEE FATALITY

Canadian National Railway Company
Assignment L57211-04
Mile 1.03, Pelletier Subdivision
Edmundston Yard
Edmundston, New Brunswick
04 December 2018

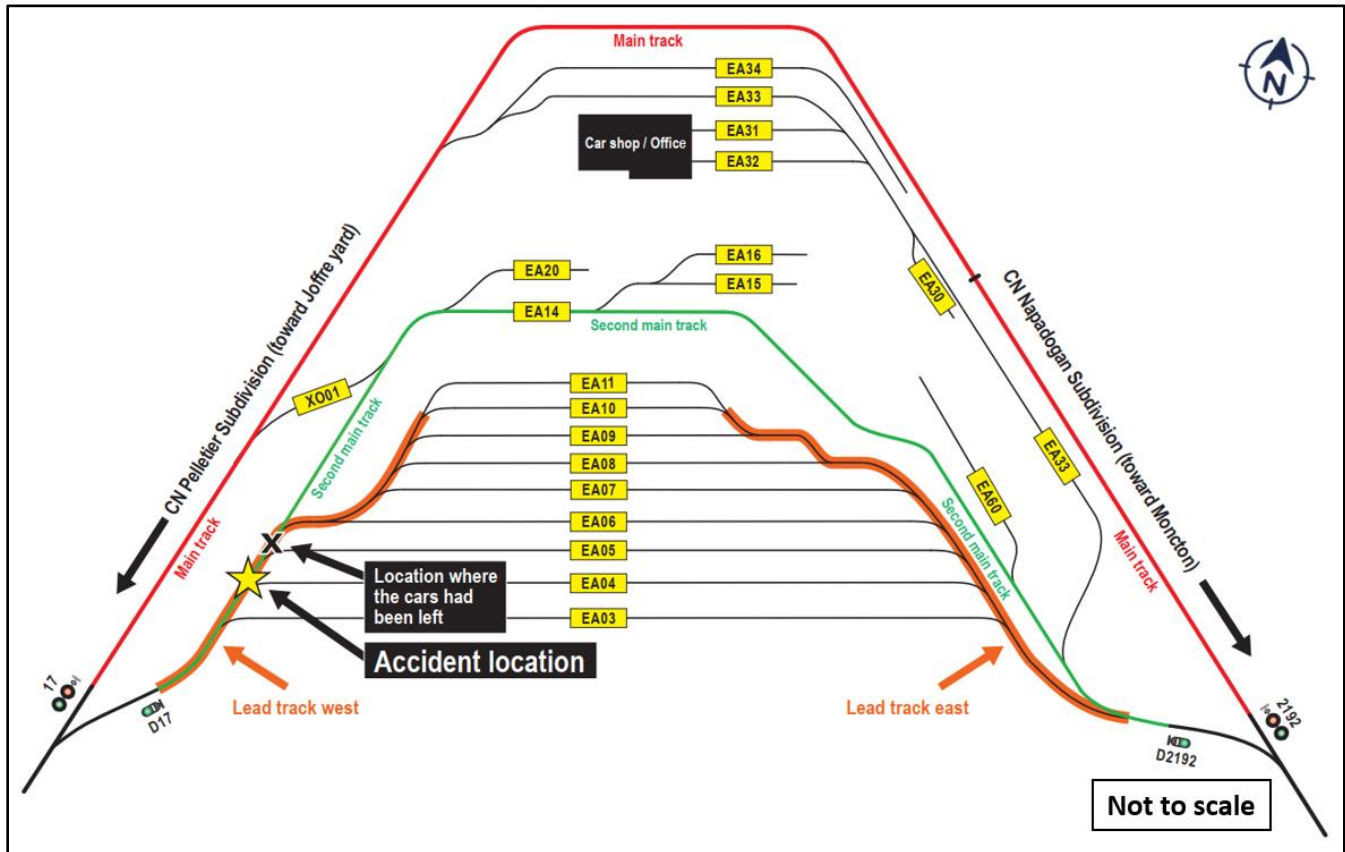
Figure 2. Diagram of Canadian National Railway Company's Edmundston Yard, showing the location of the accident (Source: TSB)

Edmundston Yard has 2 main tracks, 11 yard tracks, and several service tracks, as well as a car shop and administrative office (Figure 2).
