RAILWAY INVESTIGATION REPORT

R99H0009

COLLISION AT CROSSING

VIA RAIL CANADA INC.

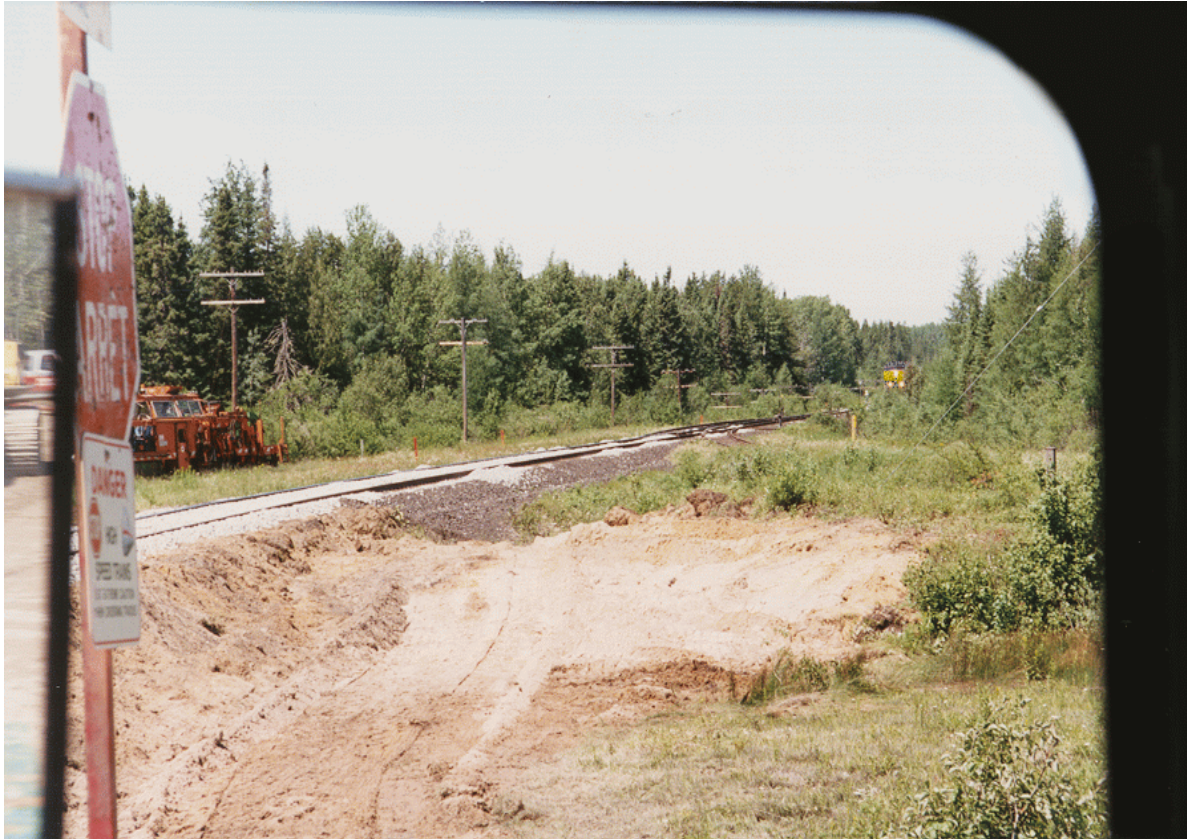
In order to obtain these sight-lines, a similar truck as the one involved in the collision was used and the sight-lines were measured in road increments of 15 m. It was noted that the side mirrors on the tractor unit did not obscure the driver's ability to see either east or west to any significant degree. Figure 7 shows the view from the truck while stopped at the north stop sign with a train approaching from the west (approximately 10 seconds away). The photograph has been taken in such a way as to approximate human eye's magnification.

³ Obstructed: looking through small trees with rear-view mirror interference
