RAILWAY INVESTIGATION REPORT

R99H0010

DERAILMENT AND COLLISION

MONT-SAINT-HILAIRE, QUEBEC

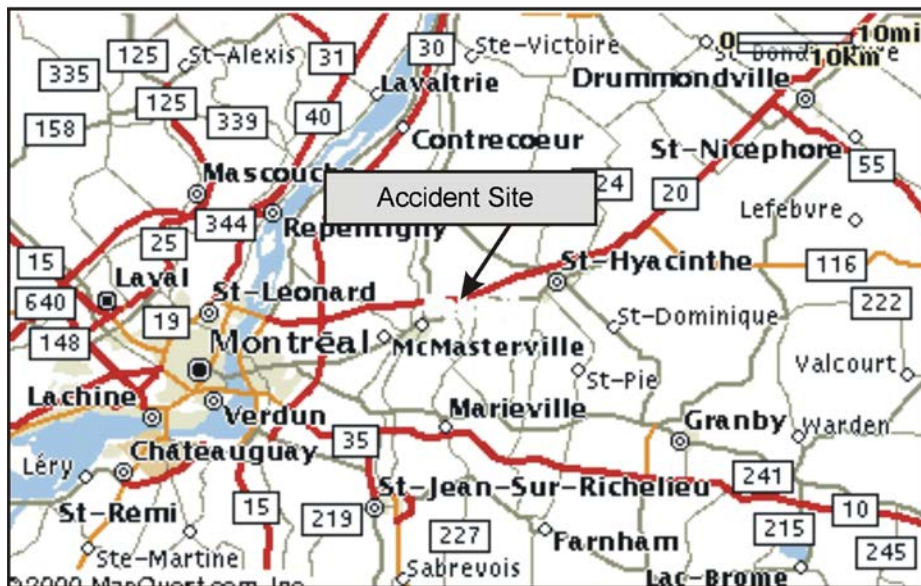
On 30 December 1999, Canadian National (CN) train No. U-783-21-30 (train 783) was travelling westward on the north track of the Saint-Hyacinthe Subdivision. CN train No. M-306-31-30 (train 306) was travelling in the opposite direction on the south track. At approximately 1900 eastern standard time (EST),<sup>1</sup> after the crossing at Benoît Road in Mont-Saint-Hilaire, Quebec (see Figure 1), the locomotives from train 783 passed the locomotives from train 306 at Mile 50.84. Immediately after, the brakes went into emergency on train 783 and the locomotive engineer noticed a ball of fire towards the rear of the train caused by an explosion. The conductor immediately made an emergency broadcast on the radio. After the train came to a stop, the crew members on train 783 tried unsuccessfully to contact the crew on train 306.

The conductor checked the train and observed that it had separated after the 11th car and that the rear truck of that car had derailed. He also saw that cars from both trains had derailed and caught fire.
