RAILWAY INVESTIGATION REPORT

R99S0100

CROSSING COLLISION/DERAILMENT

VIA RAIL CANADA INC.

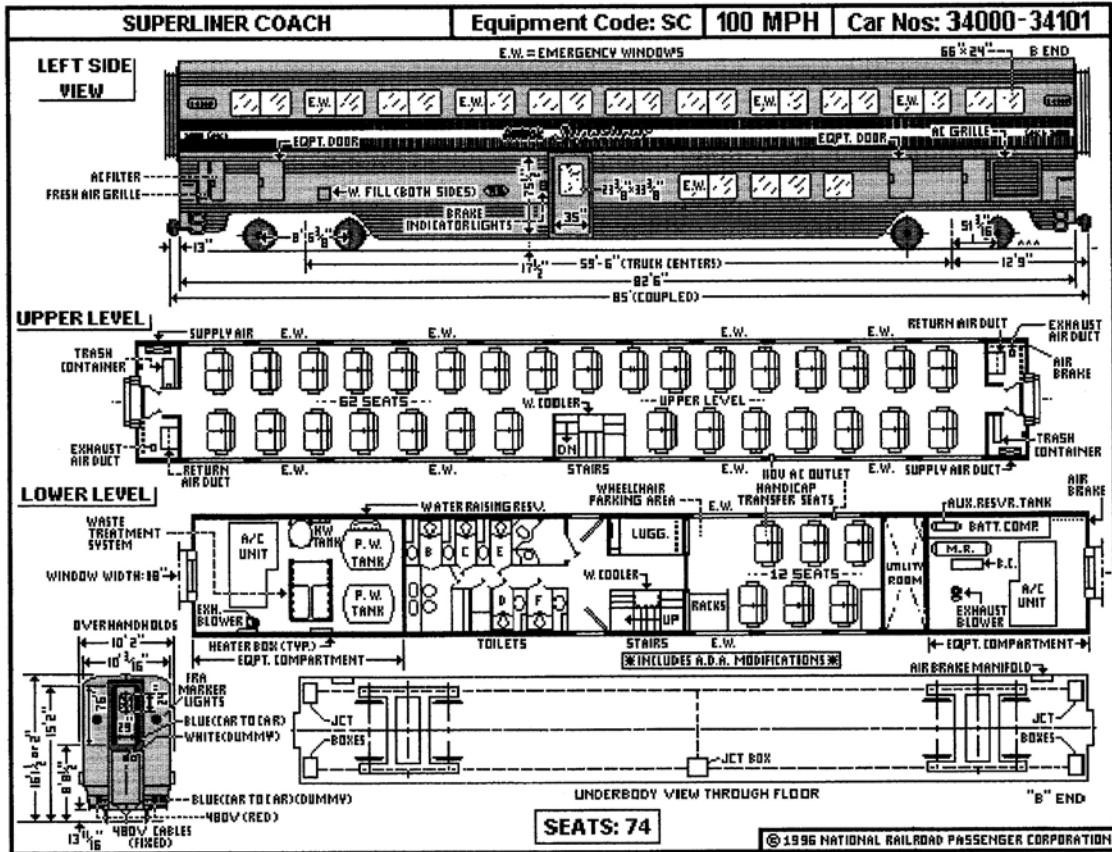
Appendix B—Profile Drawing for AMT 34000 Series Cars

Heavy post-accident damage to the coaches resulted in deformation of the car body and upper deck stairwell, which heavily impeded egress from the washrooms and upper seating area. The side sheathing and structural side post of AMT 34036 were extensively damaged when the coach struck the detached locomotive trucks, tearing a large hole in the side sheathing. The cars are designed to resist an inward transverse load; however, the loads experienced were in excess of the design requirement.
