**TRANSPORTATION SAFETY BOARD OF CANADA  
ANNUAL REPORT TO PARLIAMENT 2023–2024**

Annual Report to Parliament 2023–24

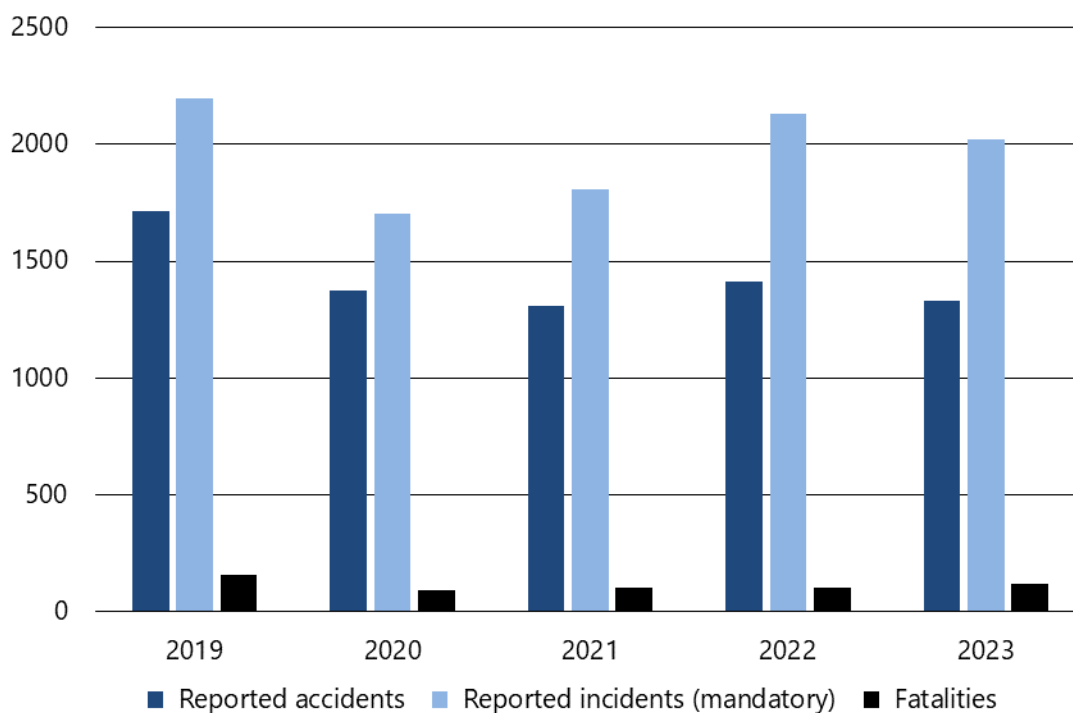
Figure 1. Transportation occurrences reported to the TSB, 2019 to 2023

The total number of occurrences [reported to the TSB](#) (as required under the *Transportation Safety Board Regulations*) in the 2023 calendar year (3350) was 6% lower than the 3556 occurrences reported in 2022 (Figure 1).

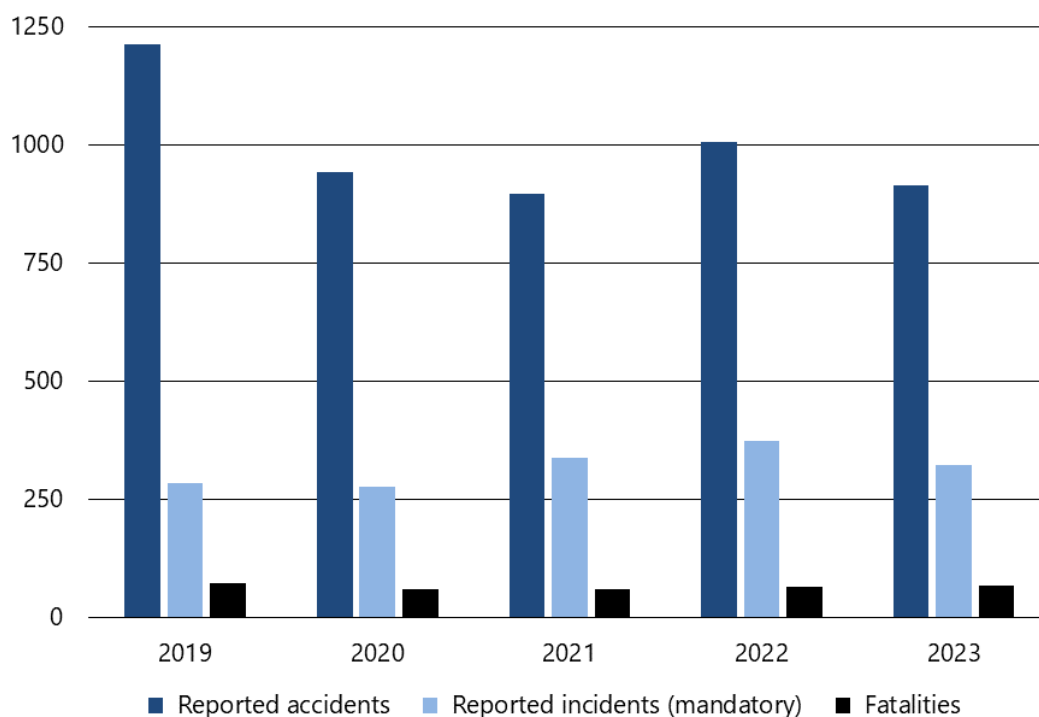
Figure 9. Rail transportation accidents, incidents, and fatalities, 2019 to 2023

The Transportation Safety Board of Canada (TSB) received 1235 reports of rail transportation occurrences in 2023 (914 accidents and 321 incidents), including 67 fatalities.

The 914 reported accidents represent a 9% decrease from 2022 and a 12% decrease from the 10-year average of 1039.

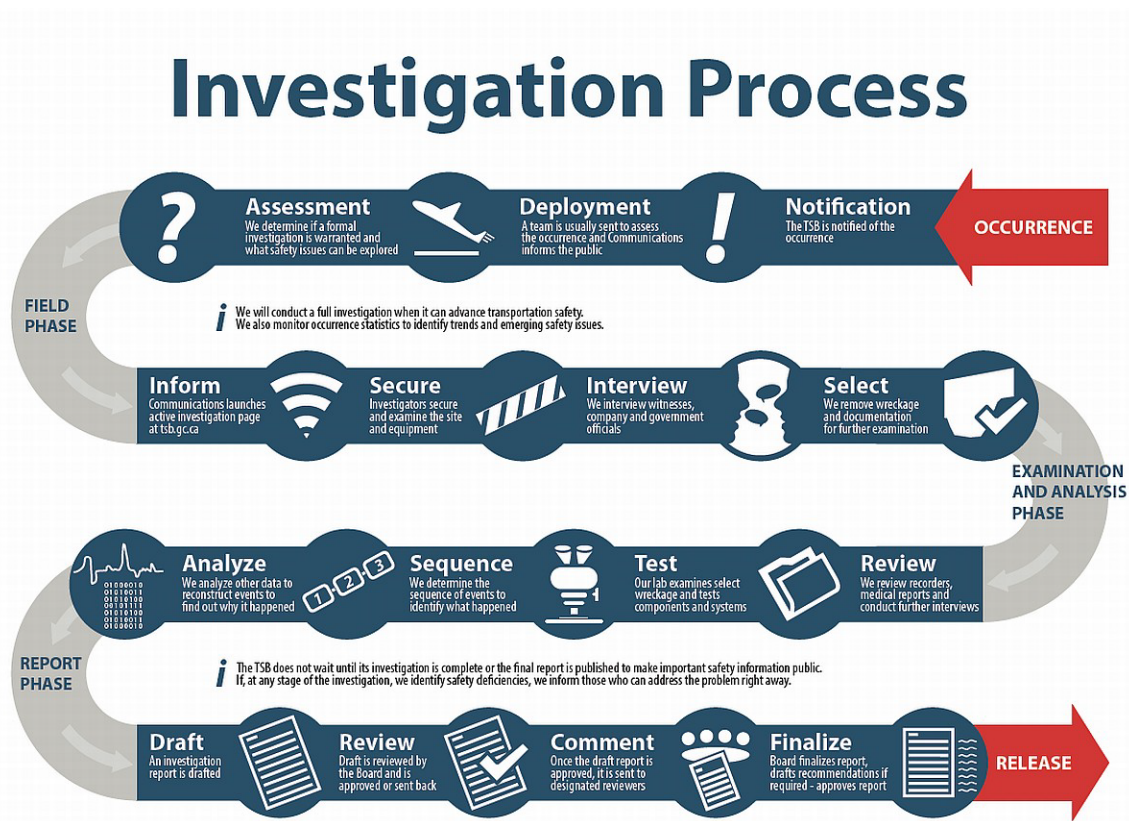
Figure 11. The TSB investigation process from occurrence to report

In the report phase, investigators draft a report on the investigation, which then goes through a review and approval process, prior to public release.

Once the Board approves the final report, it is released to the public on the TSB website and through traditional and social media.
