AVIATION OCCURRENCE REPORT

COLLISION WITH TREES

**NAVAIR CHARTER INC.
PIPER PA-31 (NAVAJO) C-GKNB
KAMLOOPS, BRITISH COLUMBIA 7 NM ESE
22 NOVEMBER 1995**

REPORT NUMBER A95P0268

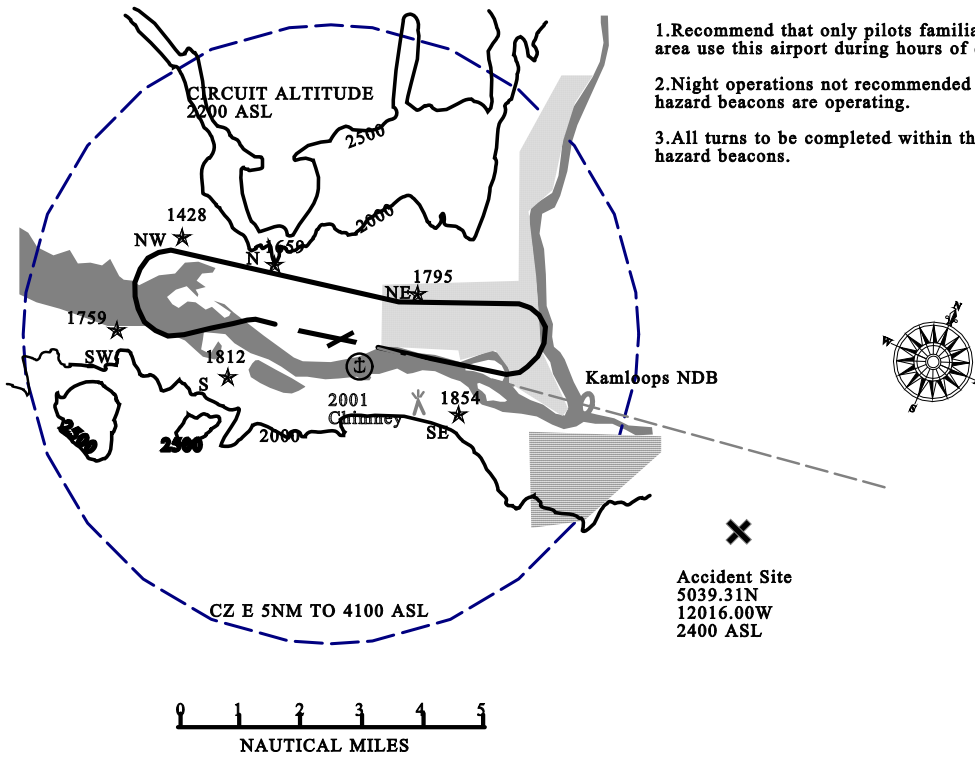
NIGHT CIRCUIT PROCEDURES

1. Recommend that only pilots familiar with the local area use this airport during hours of darkness.
2. Night operations not recommended unless all 6 hazard beacons are operating.
3. All turns to be completed within the perimeter of the hazard beacons.

Although risks are always present during night visual flight operations, the risks are even higher in mountainous regions because of the high terrain that surrounds many airports. The published night circuit procedure for the Kamloops airport recommends that only pilots familiar with the local area use the airport during darkness, that all six hazard beacons which identify the circuit area be operational, and that all turns be completed within the perimeter of the hazard beacons. The hazard beacons were operating normally at the time of the accident.
