MARINE INVESTIGATION REPORT

M00M0106

GROUNDING

TUG *KETA V*

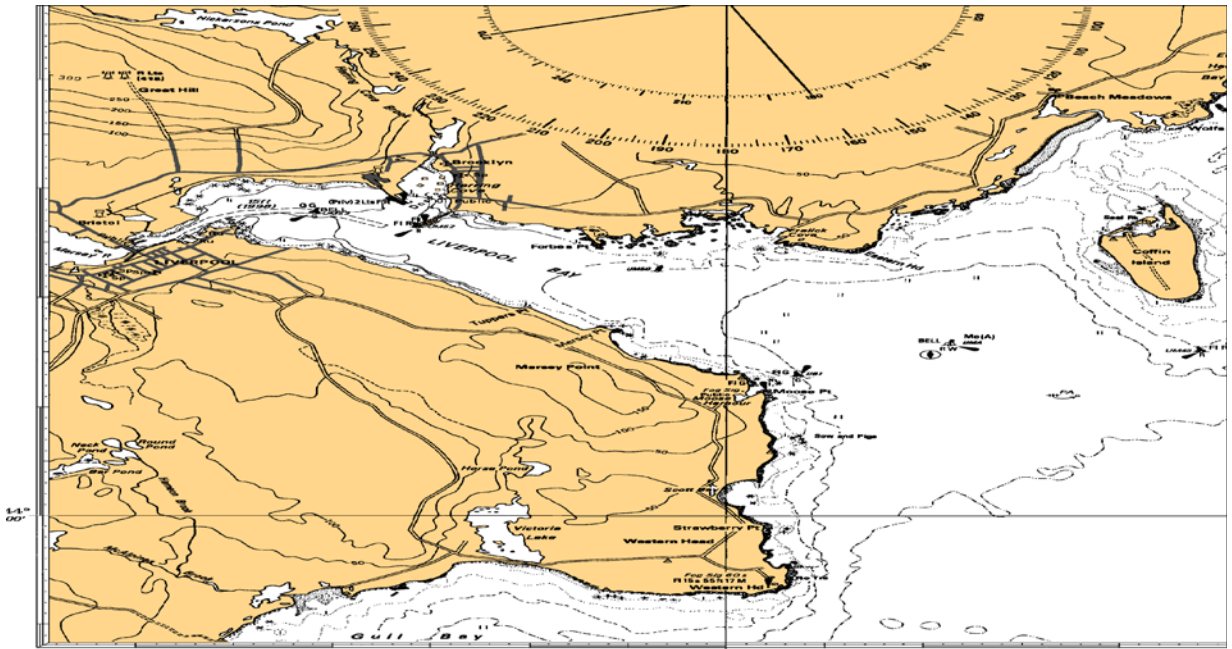
THE INFORMATION ON THIS SKETCH WAS COMPILED BY THE I.S.B. MARINE INVESTIGATIONS BRANCH. ALL TRACKS AND POSITIONS ARE APPROXIMATE. BASED ON AN ELECTRONIC NAVIGATION CHART (ENC) PROVIDED BY THE CANADIAN HYDROGRAPHIC SERVICE (CHART No 4211) AND NAUTICAL DATA INTERNATIONAL, INC.

The approach plan was to proceed on a heading of 292° T, to a position southeast of Moose Point. The engines were set to reduced speed. (See Appendix B.) On arriving at Moose Point, the master altered course to 353° T and headed for Eastern Head. While under way, the master's primary concern was to watch for presumed range lights indicating the entrance to Liverpool Harbour, which, according to him, should have been seen on the port side. The range lights were not seen. The tug maintained heading, and at 2328, it grounded on a rock shoal off Eastern Head.
