MARINE INVESTIGATION REPORT

M16P0378

Articulated tug-barge

Tug *Nathan E. Stewart* and tank barge *DBL 55*

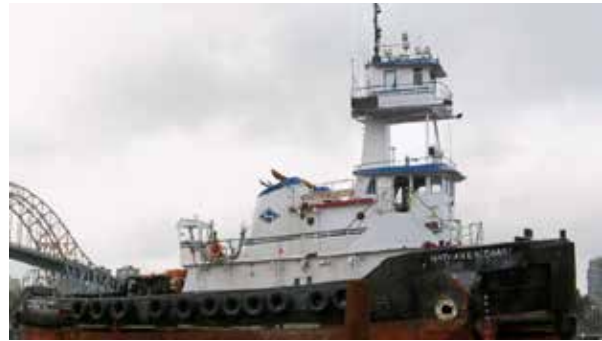
Figure 1. The *Nathan E. Stewart*

The *Nathan E. Stewart* was a conventional harbour and deep-sea towing tug of steel construction (Figure 1). It had an upper and lower wheelhouse for navigating. The upper wheelhouse could be accessed through an internal stairwell from the lower wheelhouse. It had an open layout, with windows that provided a nearly all-around, unobstructed view, and there was a chair in the middle of the space. The navigation of the tug was normally conducted from the upper wheelhouse.

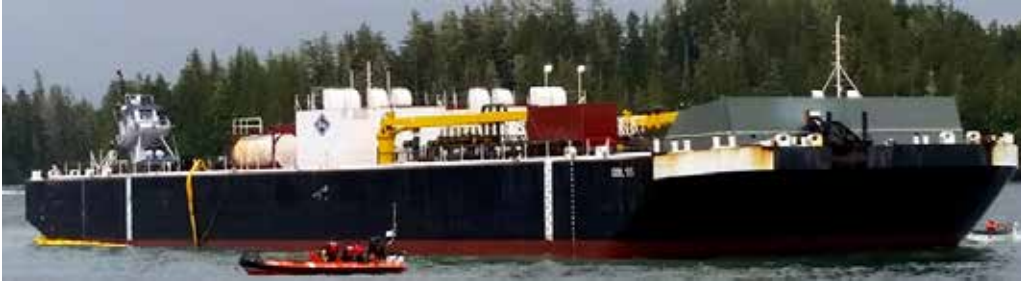
Figure 2. Tank barge *DBL 55*

The *DBL 55* is a double-hulled⁴ tank barge with 14 cargo tanks, and is certified to carry 52 000 barrels⁵ with a maximum displacement of approximately 11 000 long tons.⁶ It is also certified to carry 116 long tons of deck cargo. On deck, the barge is equipped with 2 diesel oil service tanks, 2 holding tanks, and 300 m of pollution boom and absorbent pads. It has a raked bow designed for ease of movement in sea conditions and a 9.7 m deep V-shaped indent at the stern to accommodate the bow of a pushing tug (Figure 2).

When the *Nathan E. Stewart* is in pushing mode, the bow of the tug is secured to the V-shaped indent at the stern of the barge with pneumatically operated pins. These pins create a hinge between the tug and the barge that allows for their differing movements during transit. When the 2 vessels are connected in this manner, they become an articulated tug-barge (ATB).

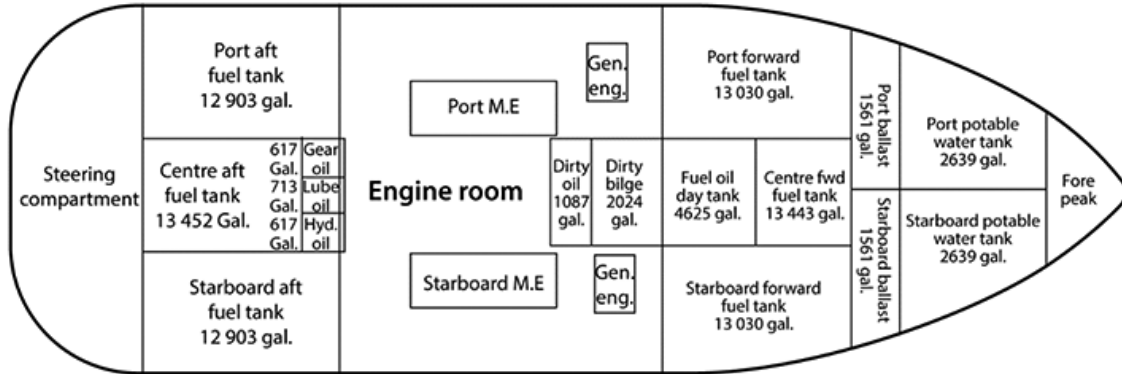
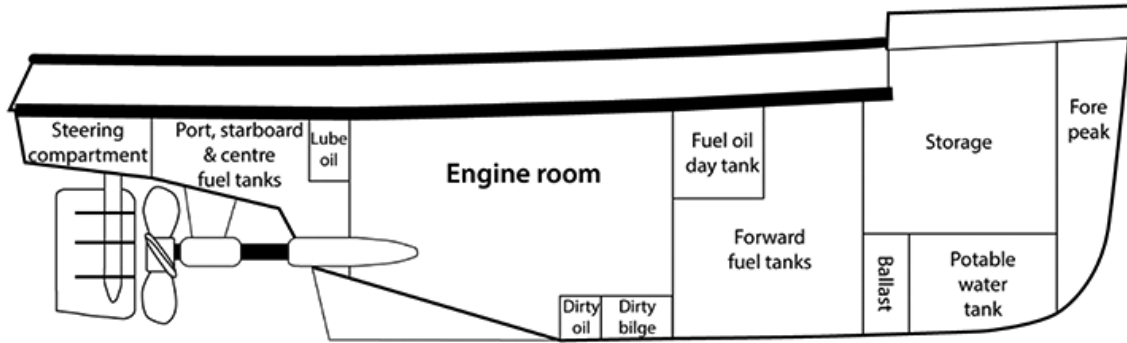
Appendix A – General arrangement of the Nathan E. Stewart

95' 3" X 32' X 18' 9"
 TWIN SCREW TUG
 BUILT 2001
 Hope Services, LA
 OFFICIAL No 1120997
 HULL Number 142
 HP 3200

FUEL OIL.....88 664 gal.
 LUBE OIL.....713 gal.
 BALLAST, FWD.....3122 gal.
 POT. WATER.....5278 gal.

Below the main deck was the fore peak, storage compartment, engine room, and steering compartment. The port and starboard pneumatically operated pins, which were used to connect the tug and barge, were located in the storage compartment. There were also 3 aft and 4 forward fuel tanks, as well as additional oil tanks for lubricant, gear oil, hydraulic oil, used oil, and bilge water (Appendix A).³

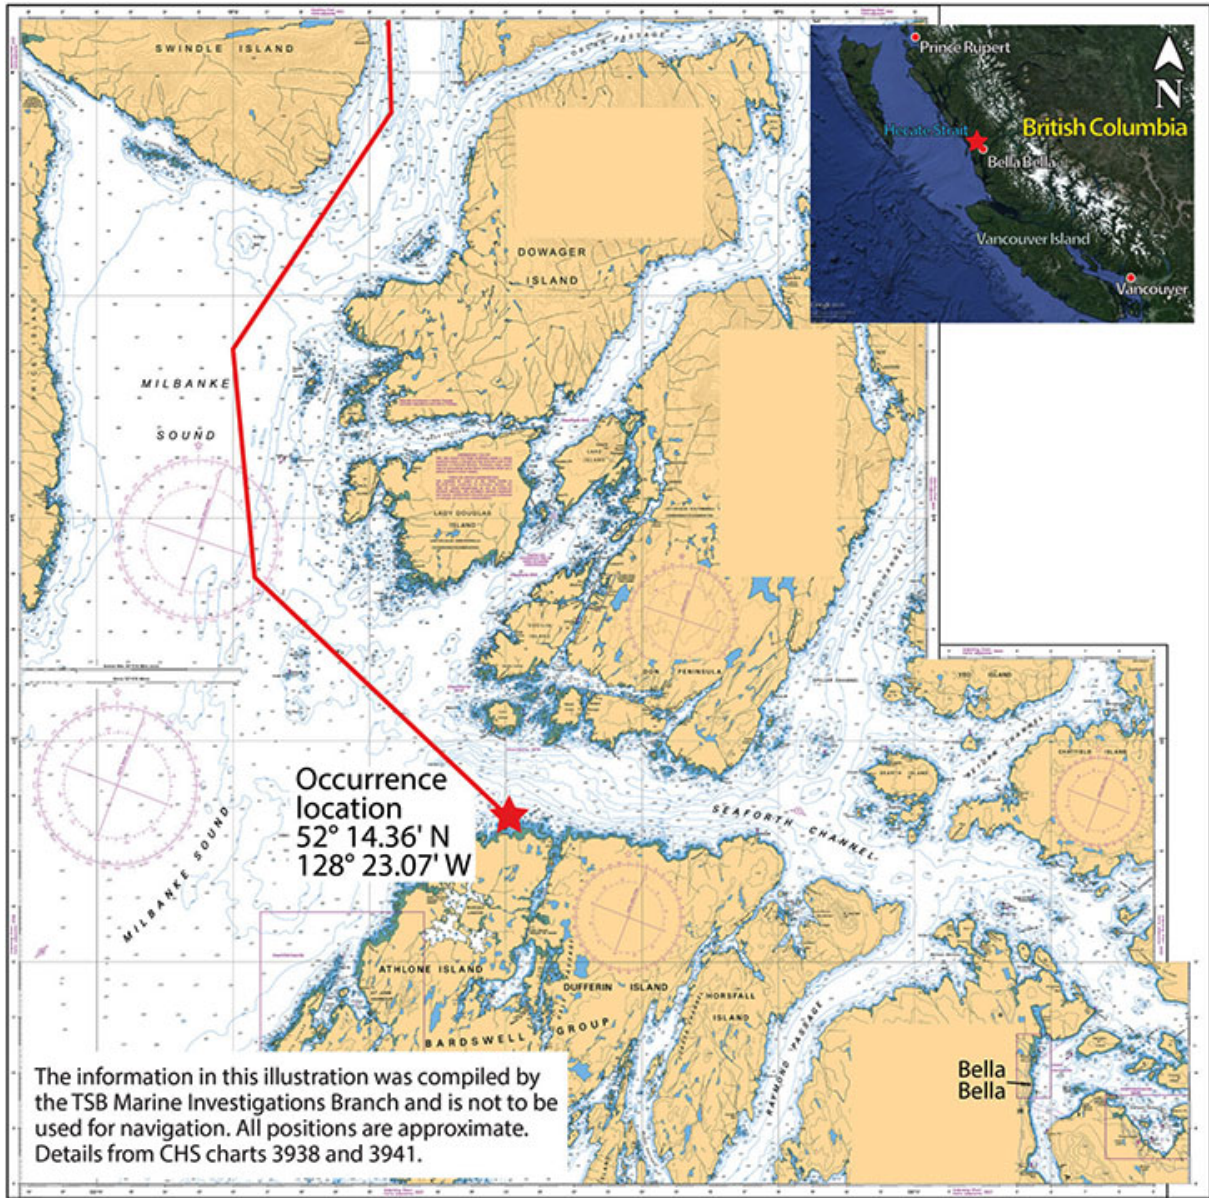
Appendix B – Area of the occurrence

Source: Canadian Hydrographic Service and Google Earth, with TSB annotations

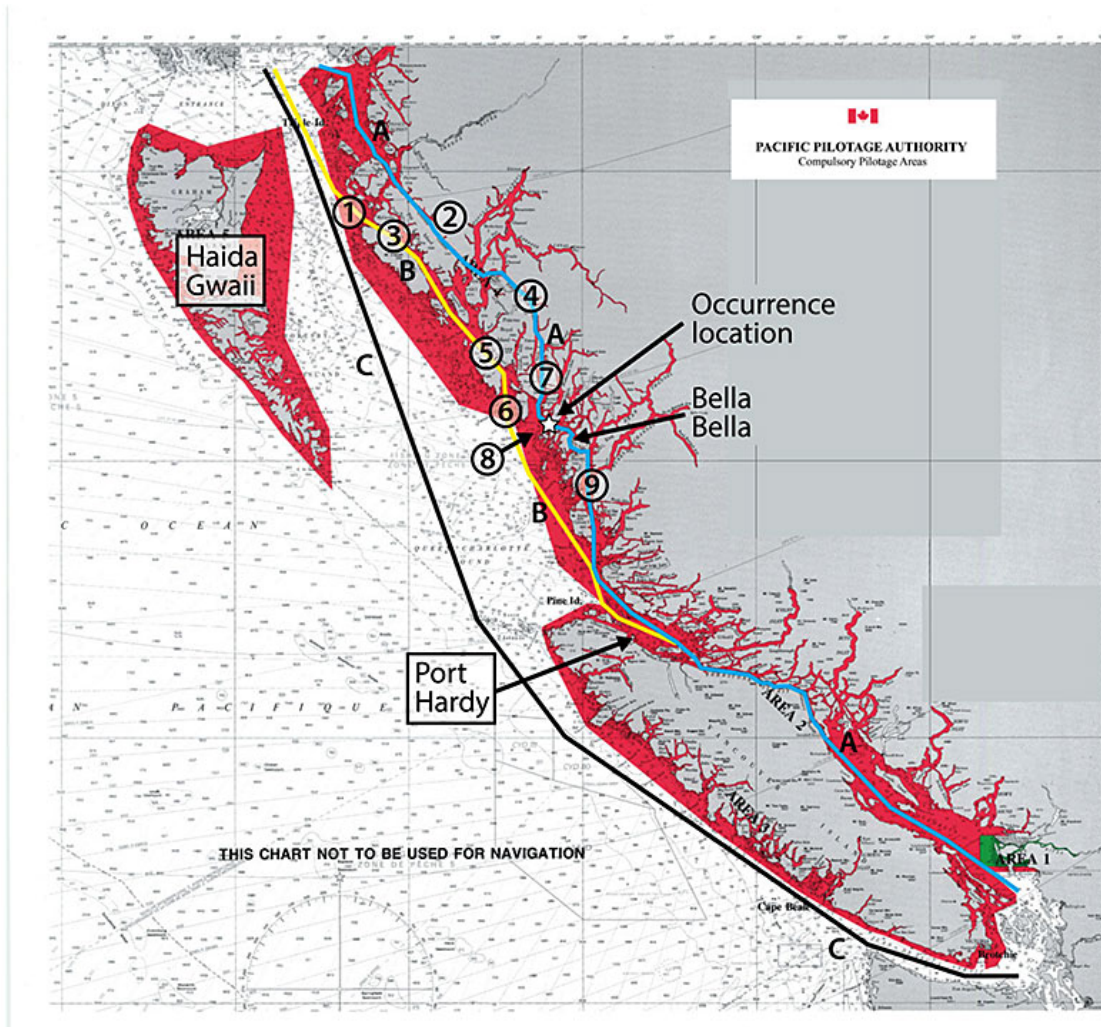
Appendix C – Compulsory pilotage waters and Inside Passage

Source: Pacific Pilotage Authority Canada, with TSB annotations
