## Marine Occurrence Report

### Crankcase Explosion

Oil Tanker "IRVING NORDIC"  
off Île aux Oeufs, Quebec  
11 March 1993

Report Number M93M0002

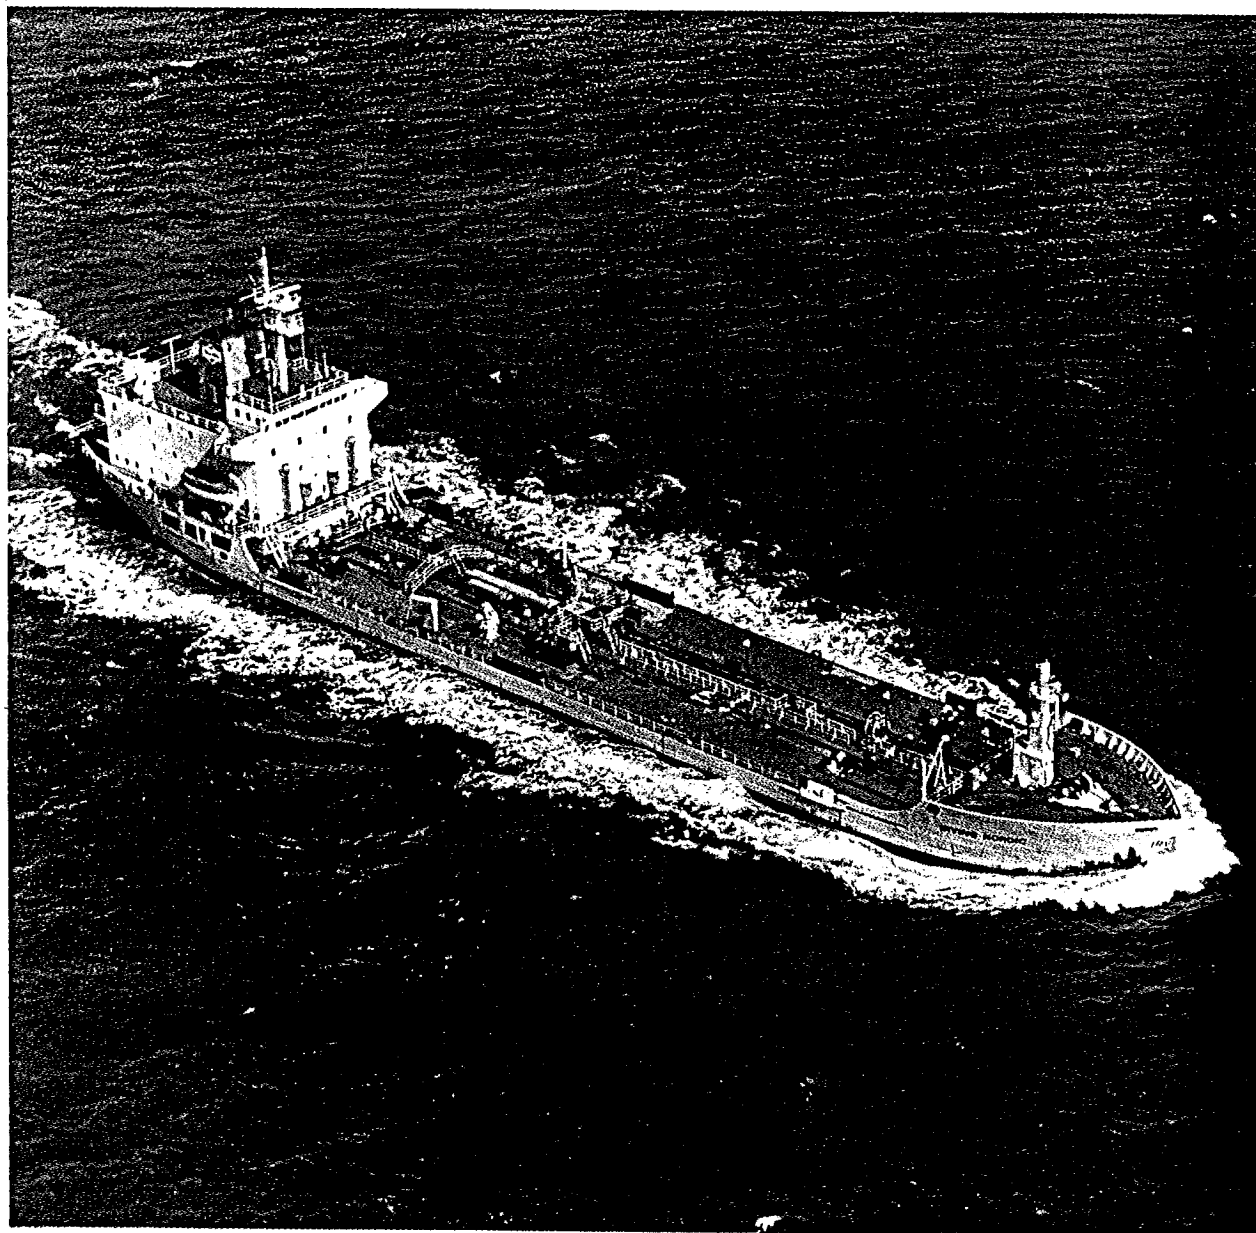
*Appendix C - Photograph***IRVING NORDIC**

The M.V. "IRVING NORDIC" is an ice-strengthened product carrier designed to carry refined oil cargoes.
