RAILWAY INVESTIGATION REPORT
R00T0067

MAIN TRACK TRAIN DERAILMENT

ONTARIO NORTHLAND RAILWAY
FREIGHT TRAIN NO. 402
MILE 63.4, TEMAGAMI SUBDIVISION
TEMAGAMI, ONTARIO
14 MARCH 2000

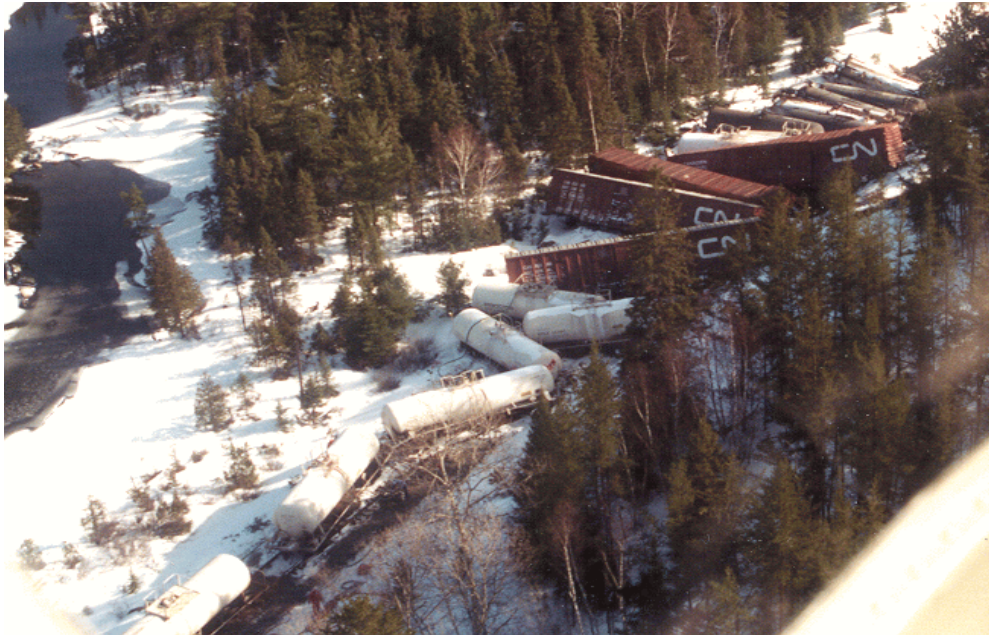
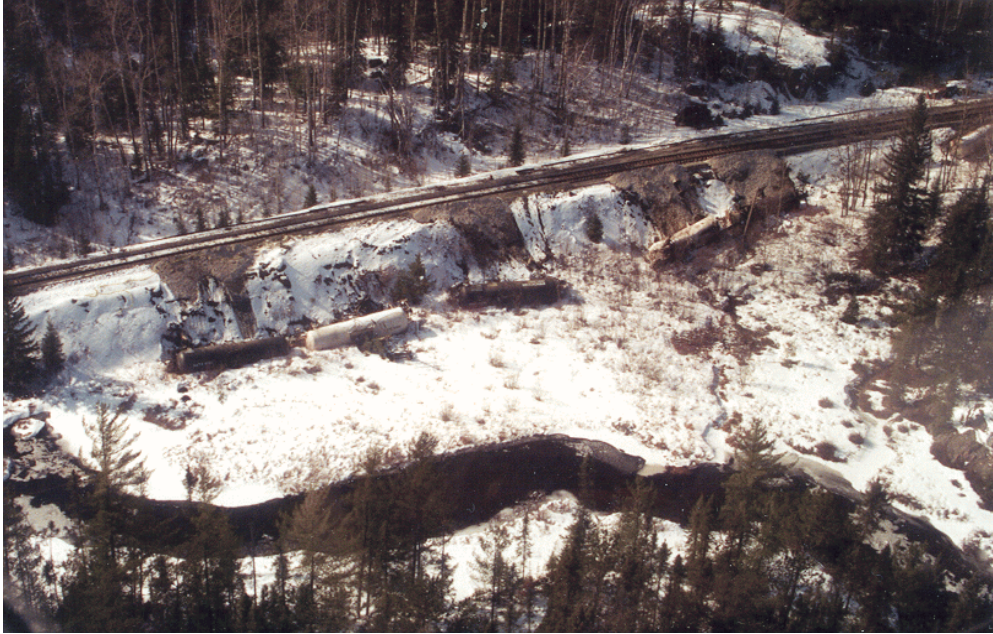
the north end of the derailment site. Most of the remaining 144 000 litres of acid flowed into Martin Creek which runs parallel to the rail track at the south end of the derailment site. An estimated 35 000 litres of sulphuric acid which spilled into the creek migrated to Hornet Lake.

Twenty-three of the derailed cars were extensively damaged. It was determined from the location of the wreckage that the 17th car (UTLX14536) from the locomotives likely derailed first and the rigid connection of the double-shelf couplers between the tank cars resulted in the derailment of four cars ahead, the 16th, 15th, 14th and 13th cars behind the locomotives. A post-derailment inspection of the running gear on the first derailed car did not indicate that there were any mechanical defects that likely contributed to the derailment. Approximately 1 100 feet of track was destroyed.

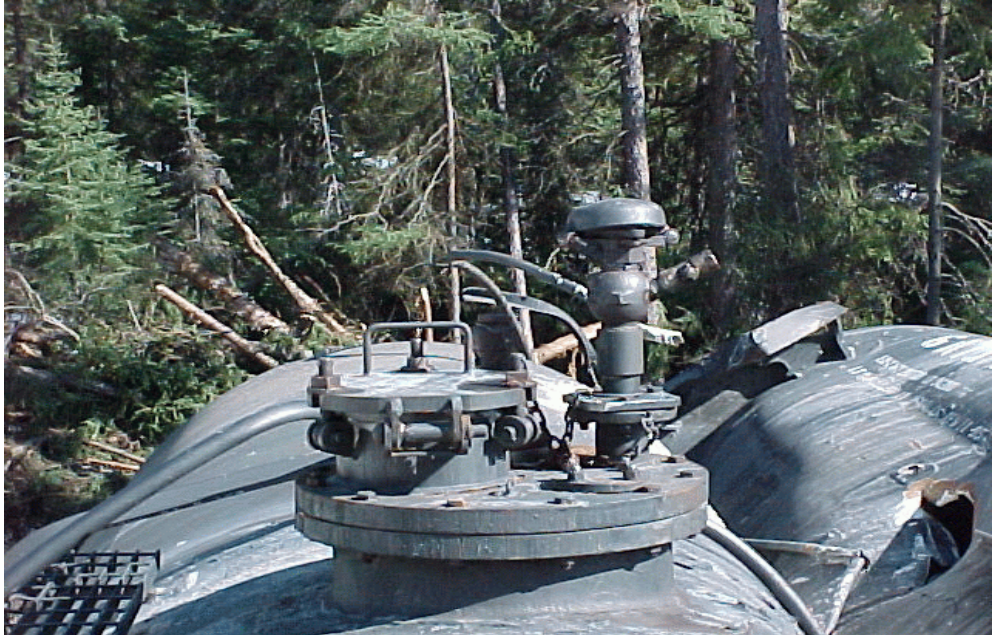
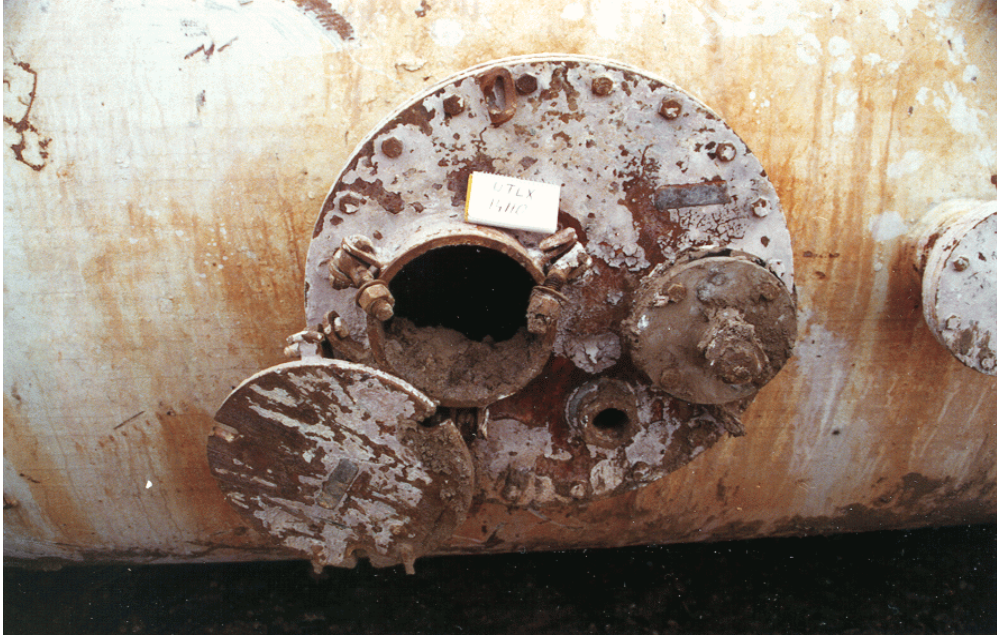
The typical arrangement of the upper part of a sulphuric acid tank car includes a fill hole which is usually about eight inches in diameter, a discharge outlet which is about two inches in diameter, an air connection and valve which is usually one inch in diameter and contains a rupture disc assembly. The rupture disc covers the opening in the safety vent. The safety vent is a device designed to relieve excess pressure from the inside of the tank but does not close after it is ruptured. Although many general service specification 111 tank cars have safety valves that close after excessive pressure is released, tank cars in sulphuric acid service have rupture discs instead. The use of rupture discs is preferable to safety valves where the assembly is exposed to corrosive products such as acid. A typical arrangement of the appurtenances on the top of a sulphuric acid tank car is depicted in Figure 3. It should be noted that there was no top fitting protection on any of the tank cars involved. Figure 4 shows the tank with top fittings sheared off. Tank cars leased by Noranda Inc. are equipped with hydro-damps to reduce the risk of rupture disc failure by reducing the sloshing of the liquid acid.

In order to transport sulphuric acid, purpose-built tank cars are used because of the high density of the product. A typical tank car for sulphuric acid service is about 45 feet long, with an empty weight of about 27 tons. The volume of the tank is typically about 50 000 litres which translates into a fully loaded weight of about 130 tons. Specification 111 tank cars for transportation of sulphuric acid are not permitted to have bottom outlet valves unless they are being transported as a unit train which consists of cars of sulphuric acid only. Cars with bottom unloading valves are equipped with skid plates to prevent shearing off in case of an accident. Alternatively, bottom outlet valves may be recessed into the tank. However, on tank cars such as those involved in this derailment, top fittings have no protection against shearing off in a rollover.

Any tank car used for the transportation of dangerous goods by rail in Canada must comply with the Canadian General Standards Board (CGSB) standards. Amongst these standards is a requirement that certain cars be equipped with protective housings.⁸ TC does not consider these requirements to be applicable to specification 111A tank cars used to transport sulphuric acid, including the cars involved in this derailment, because these cars do not typically have valves or fittings. In any event, these protective housing requirements are aimed at preventing vandalism of the cars equipped with valves or fittings to permit the loading and unloading of the contents and not at providing rollover protection.

The thickness of the protective housing for top fittings on specification 111 tank cars is prescribed to be a minimum of 1/8 inch. All pressurized cars built to specifications 105 or 112 require a minimum wall thickness of 3/4 inch and a minimum top thickness of 1/4 inch for protective housing.
